**AGENDA
REGULAR MEETING
LOCAL TRANSPORTATION AUTHORITY**

5. **RECEIVE** Presentation on the San Benito County Local Transportation Authority's Bus Stop Improvement Plan (BSIP) and **ACCEPT** the Final Report – Gilbert

The San Benito County Local Transportation Authority (LTA) Bus Stop Improvement Plan is a planning document that summarizes findings and details results and recommendations of the County Express Bus Stop Improvement Project. The objectives of the project was aimed to evaluate existing conditions of the bus stops operated by the LTA, incorporate input from the public with the findings, provide recommendations for improvements, costs estimates, and conceptual design, and prioritize bus stops for improvements. The key tasks of the project include the following:

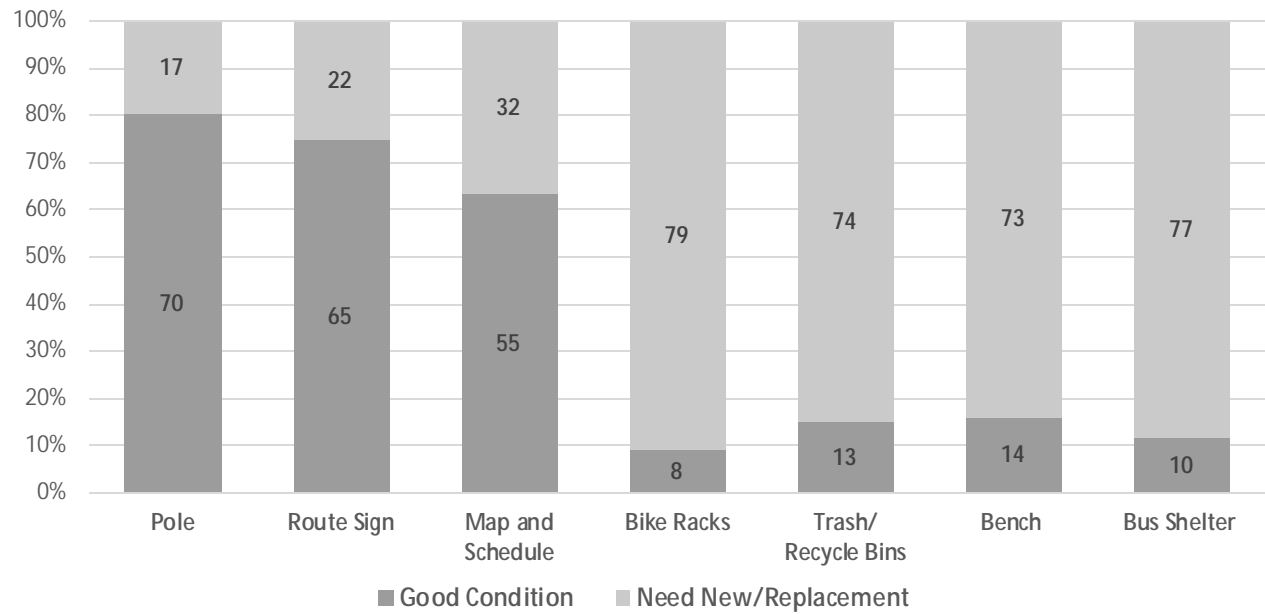
Figure 4: Existing Condition of Amenities

Table 2 summarizes the existing conditions and amenities for each bus stop. Evaluation of the existing conditions was conducted based on the data collected for each bus stop. Figure 4 illustrates the existing condition of amenities.

The following is a summary of deficiencies for the 87 bus stops operated by LTA:

- ▶ 20% of the bus stops do not have sign posts, 25% of the bus stops do not have route signs, and 32% of the bus stops do not have map and schedule;
- ▶ 7% of the bus stops are not easily accessible (missing sidewalks) and 14% of the bus stops do not wheelchair accessible;
- ▶ 29% of the bus stops do not have red curb and 83% of the bus stops do not have “No Parking Sign” at the bus stops; and
- ▶ 91% of the bus stops do not have bicycle racks, 85% of the bus stops do not have trash/recycle bins, 73% of the bus stops do not have bench, and 77% of the bus stops do not have bus shelter.

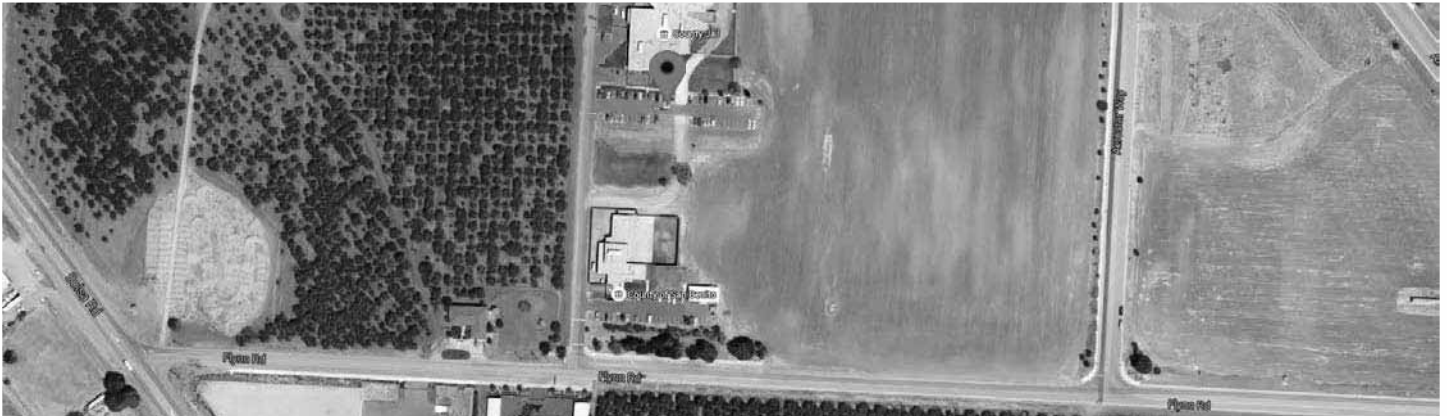
#1

Aerial view of the bus stop

- Bus stop currently serves the Red line next to the County Jail
- Fixed signpost near the handicapped parking stall
- System map, route map, and route timetable in good condition
- Adequate lighting in the street
- Public facility land use around the bus stop
- Bus stop location in the parking lot

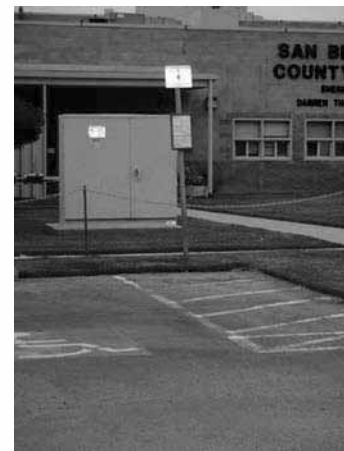
View of the bus stop

- No bus shelter or bench
- No trash can or recycling bin
- No bicycle facility along the bus route
- No bicycle racks or lockers
- No ADA compliant textured surfaces for wheelchair ramps at upstream and downstream intersections
- Not in an ideal location in the parking lot
- Not a wheelchair friendly location

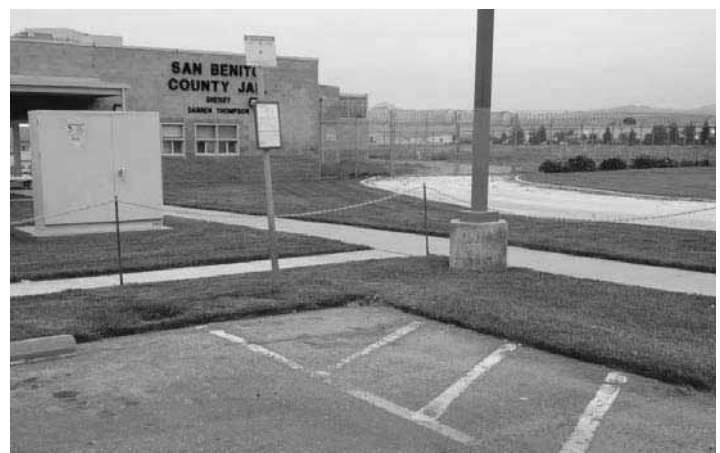
Bus stop shared space with ADA parking

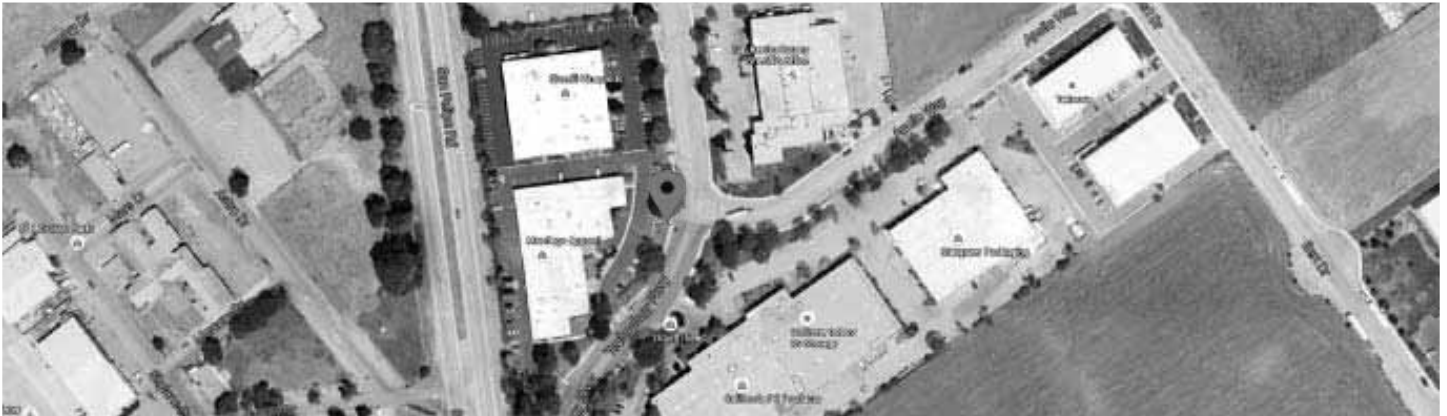
#2

Aerial view of the bus stop

- Bus stop serving Red line in southbound direction
- Adequate lighting in the street
- System map, route map and timetable in good condition
- Sidewalk along bus stop measures 5'0"
- Bus stop aligned with curb/parking lane
- Courier drop-off box obstructing the side walk.
- A light pole nearby in the middle of the sidewalk creating a tripping hazard
- Underground water meters within 100'0" of bus stop
- Nearby intersections have ADA compliant ramps
- Road surface near the bus stop is in good condition
- Bus stop located in a business park

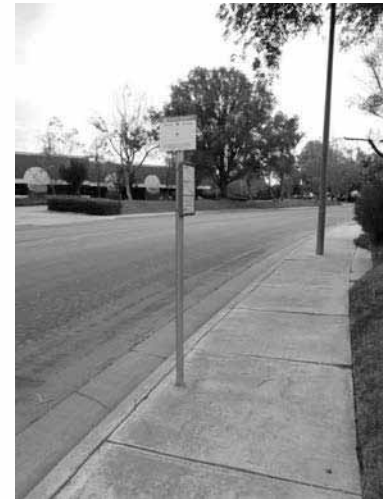
View of the bus stop

- No bus shelter or bench
- No trash can or recycling bin
- No red curb
- No bicycle facility along the bus route
- No bicycle racks or lockers
- No wheelchair ramps at the bus stop
- Obstructions to side walk (light pole, courier box) reduce the effective sidewalk width

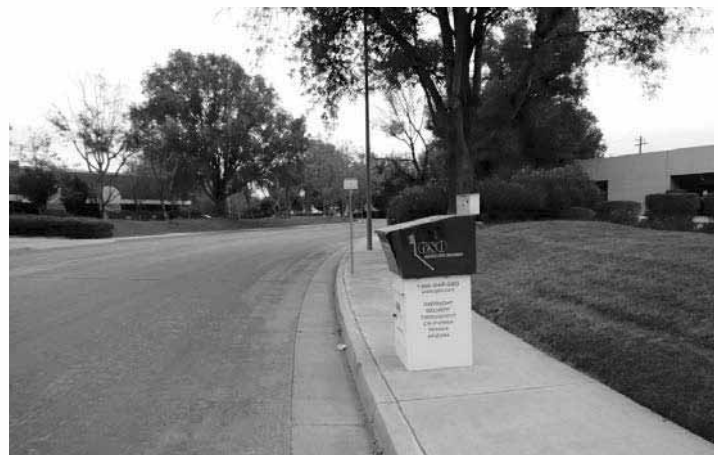
Obstructions on the sidewalk near the bus stop

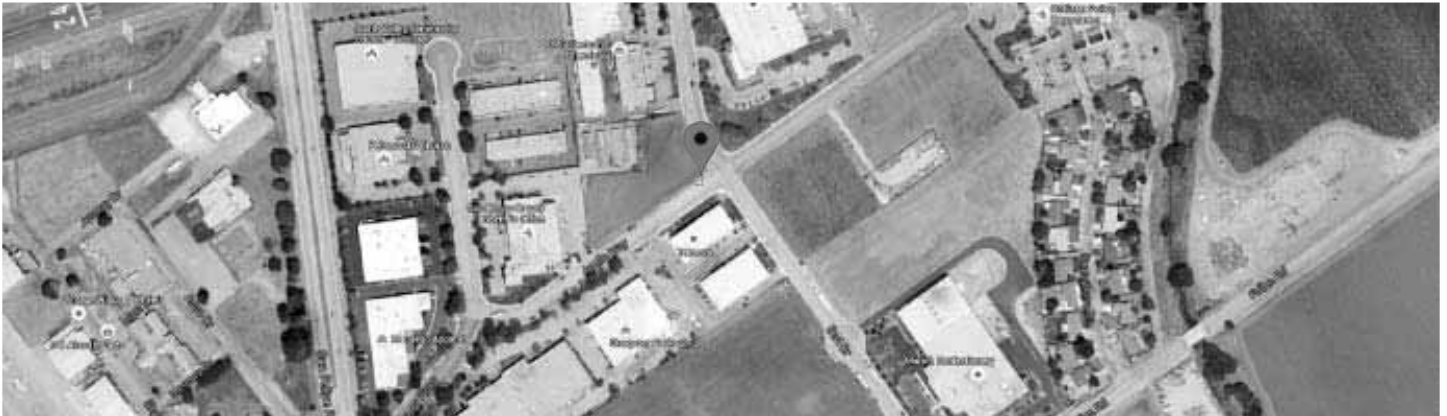
#3

Aerial view of the bus stop

Deteriorated red curb near the bus stop

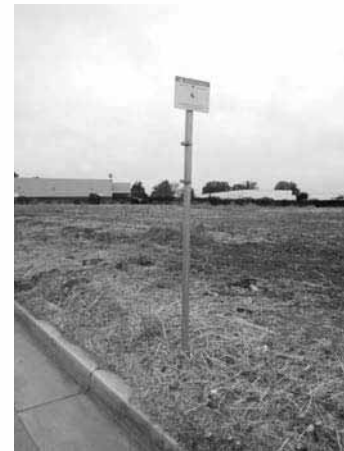
- No bus shelter or bench
- No system map, route map, or route timetable
- No trash can or recycling bin
- No sidewalk
- No bicycle facility along the bus route
- No bicycle racks or lockers
- No ADA compliant textured surfaces for wheelchair ramps at upstream and downstream intersections
- "No parking" sign and enforcement needed

View of the bus stop

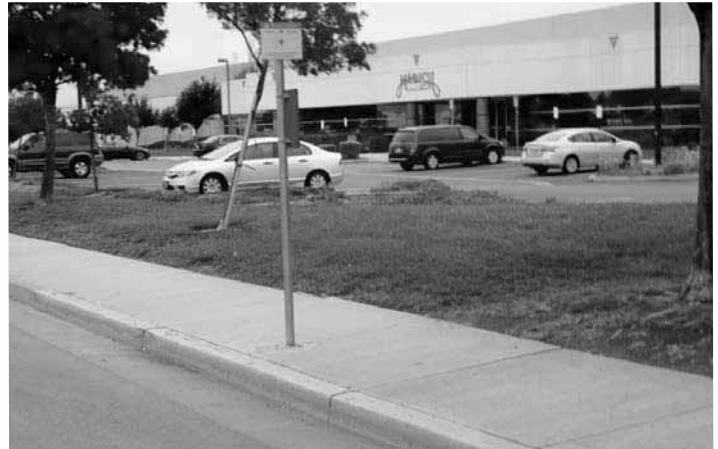
- No bus shelter or bench
- No trash can or recycling bin
- No bicycle facility along the bus route
- No bicycle racks or lockers
- No textured ramp at this intersection

View of the bus stop

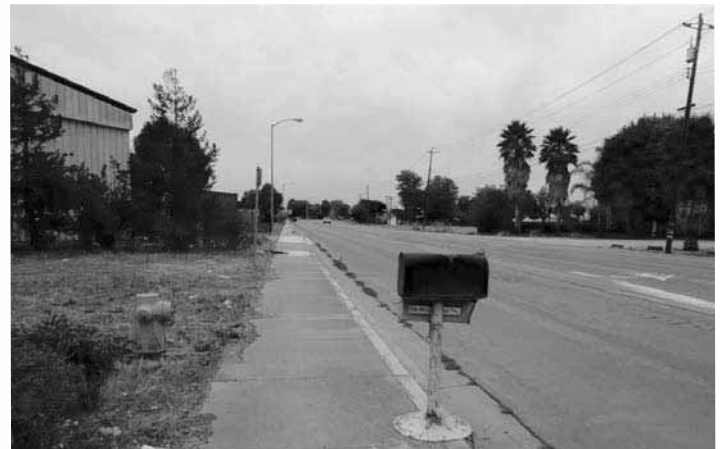
- No bus shelter or bench
- No bus stop signage
- No trash can or recycling bin
- No bicycle facility along the bus route
- No bicycle racks or lockers
- No system map, route map, or route timetable
- No ADA compliant textured surfaces for wheelchair ramps at upstream and downstream intersections
- Vehicle speed high

Red curb at the bus stop without any signage

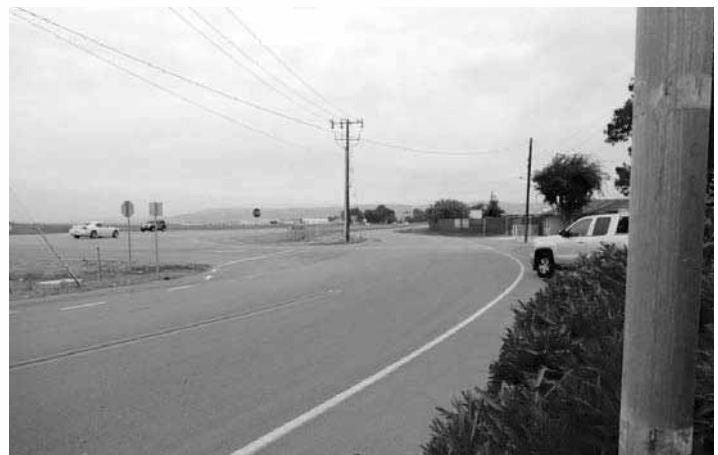
Bike lanes near the bus stop

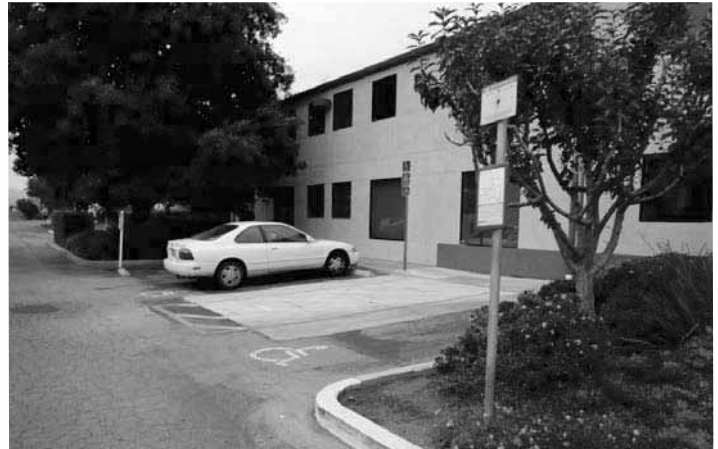
- No bus shelter or bench
- No sidewalk
- No red curb
- No recycling bin
- No bicycle facility along the bus route
- No ADA compliant textured surfaces for wheelchair ramps

View of the bus stop

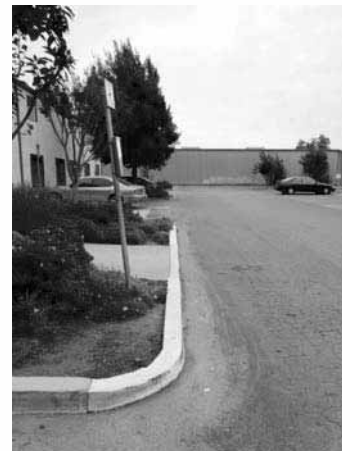
Signpost tilted

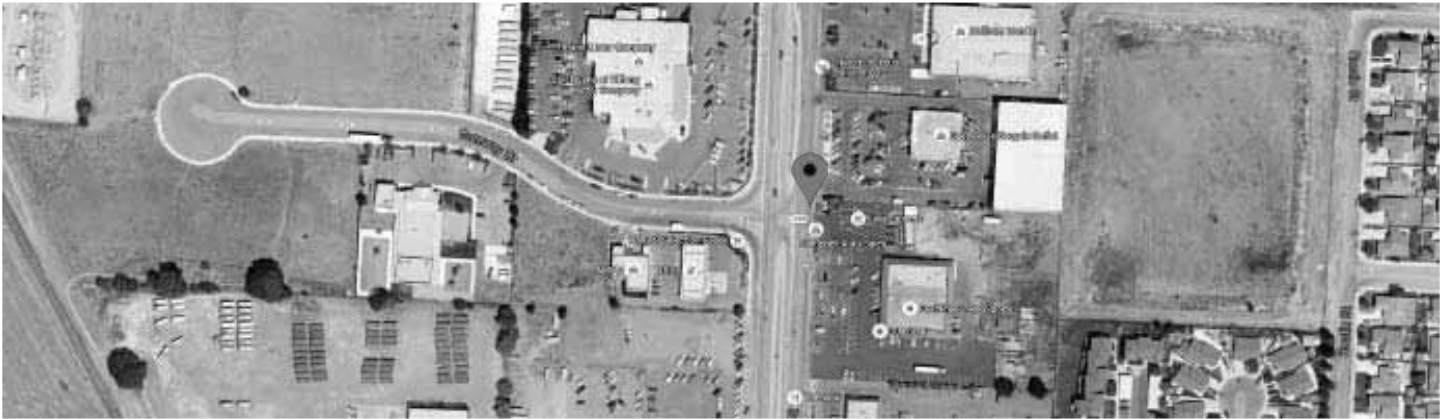
#8

Aerial view of the bus stop

- Bus stop serving Red line in the northbound direction
- System map, route map and route timetable in good condition
- Existing signpost in good condition but is missing the route information
- Adequate lighting in the street
- Class II bicycle facilities along the bus route corridor
- Vehicles driving at high speeds along the corridor
- Bus stop located on gravel
- No ADA ramps for wheelchair access
- Passengers to access the bus from a driveway creating vehicle-pedestrian conflicts
- Unsafe conditions to access the bus
- Approximately 10'0" wide shallow, uncovered, stormwater drain along the corridor
- Commercial and retail land uses around the bus stop

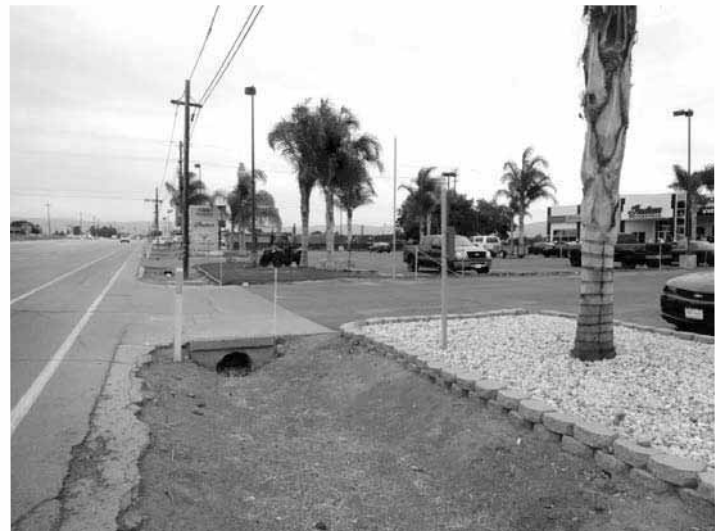
Shallow uncovered stormwater drain by the bus stop

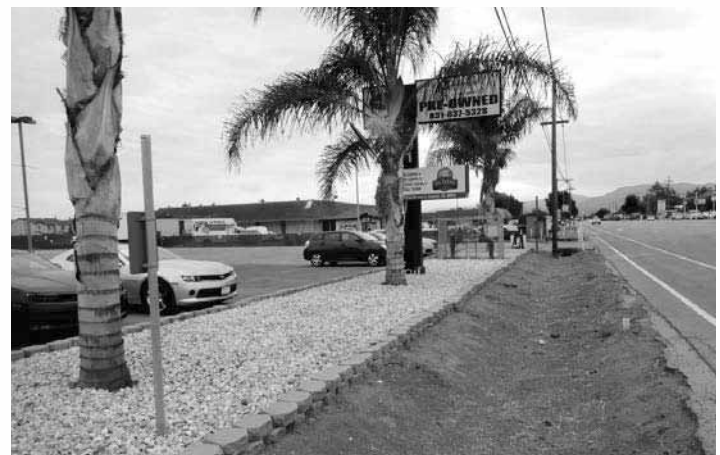
- No bus shelter or bench
- No waiting space for passengers
- No trash can or recycling bin
- No bicycle racks or lockers
- No sidewalk
- No ADA compliant wheelchair ramps at the nearby intersections
- No red curb
- Sidewalk connectivity issues

View of the bus stop

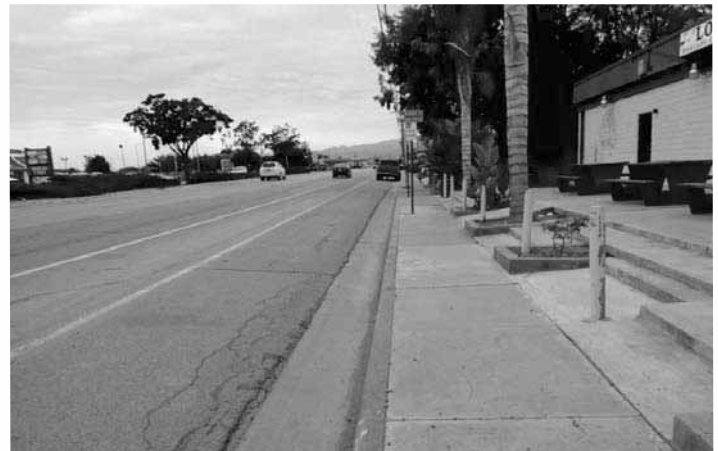
- Bus stop serving Red line in the southbound direction
- Adequate lighting in the street
- Effective sidewalk along bus stop measures 4'10"
- Bus stop location aligned with parking lane
- No signage indicating the bus stop
- Red curb at stop measures 40'0" and needs repainting
- Class II bicycle facilities along the bus route corridor
- Commercial and retail land use near the bus stop

View of the bus stop

- No trash can or recycling bin
- No bus shelters or benches
- No system map, route map or route timetable
- No bicycle facility along the bus route
- No bicycle racks or lockers
- No ADA compliant wheelchair ramps at the nearby intersections

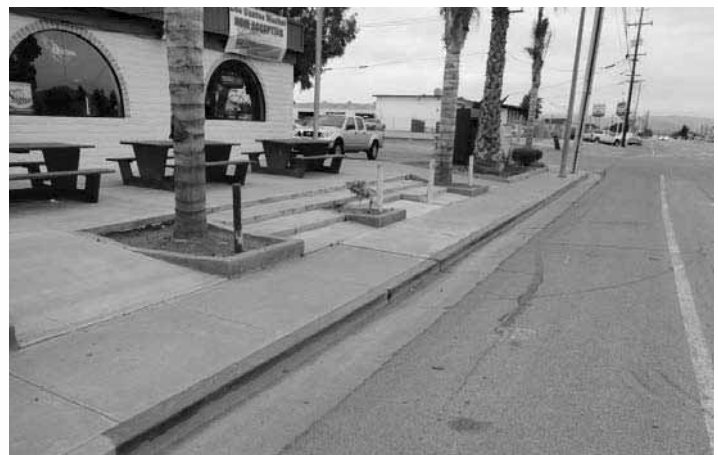
Red curb at the bus stop without any signage

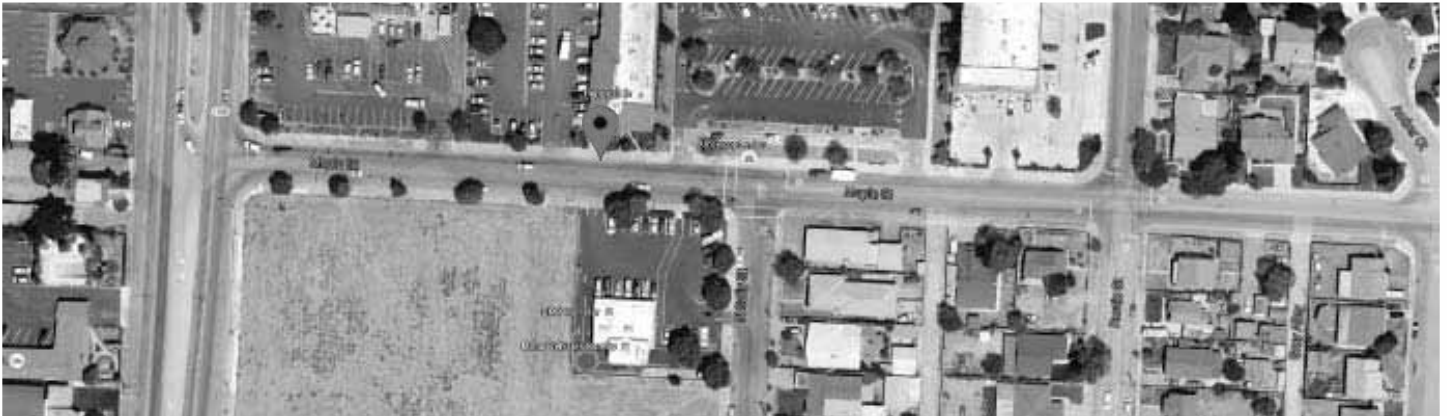
#10

Aerial view of the bus stop

- Bus stop serving Red line in the northbound direction
- System map, route map and route timetable in good condition
- Signpost is in good condition
- Adequate lighting in the street
- Sidewalk along bus stop measures 9'6"
- Bus stop location aligned with curb/parking lane
- Red curb at stop measures 51'0"
- Retail and office land uses around the bus stop
- Road surface near the bus stop is acceptable but needs some minor repairs
- Existing wheelchair ramps at nearby intersections

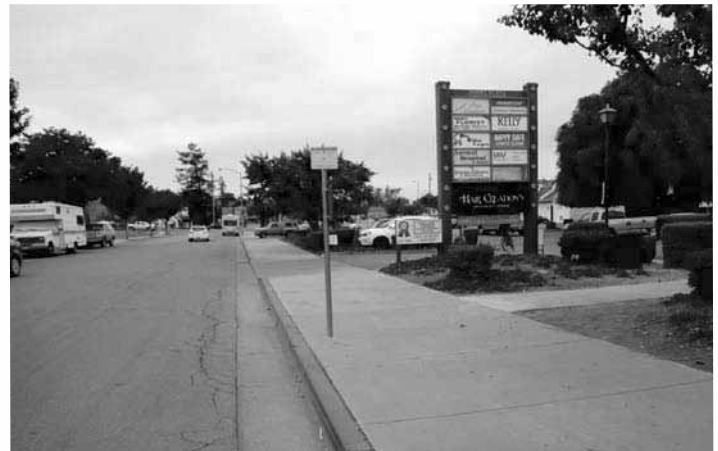
View of the bus stop

- No bus shelter or bench
- No trash can or recycling bin
- No bicycle facility along the bus route
- No bicycle racks or lockers
- No ADA compliant textured surfaces for wheelchair ramps at nearby intersections

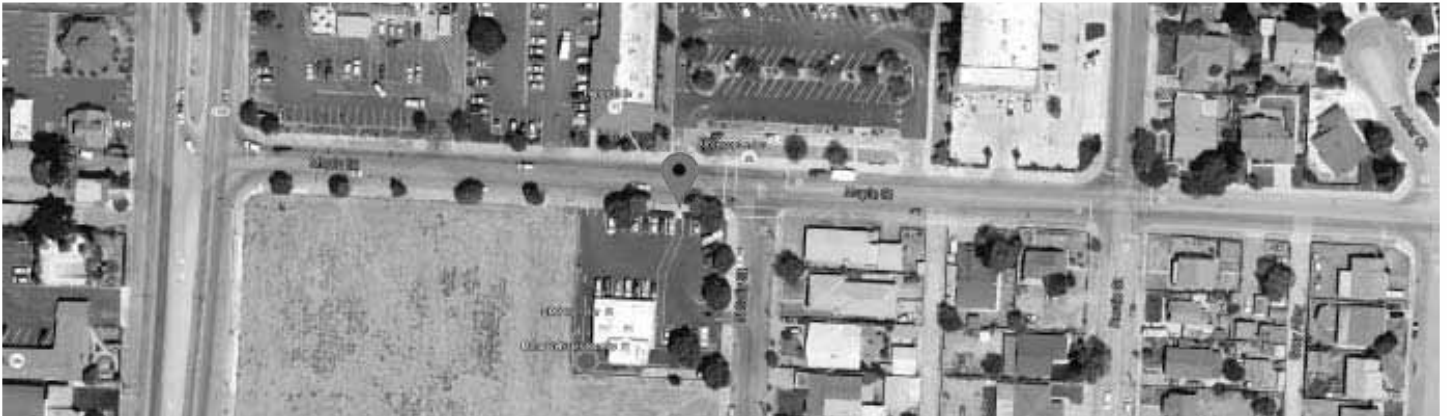
#11

Aerial view of the bus stop

- Bus stop serving Red line in the southbound direction
- System map, route map and route timetable in good condition
- Signpost in good condition
- Adequate lighting in the street
- Sidewalk along bus stop measures 9'6"
- Bus stop location aligned with curb/parking lane
- Red curb at stop measures 78'0" and is in acceptable condition
- Existing wheelchair ramps at nearby intersections

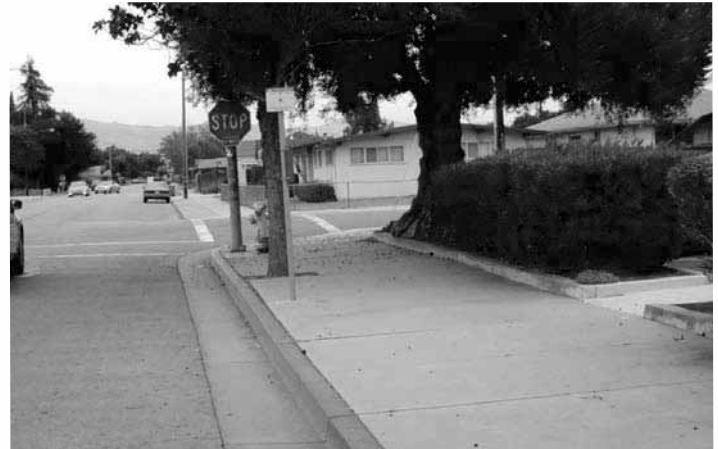
View of the bus stop

- No bus shelter or bench
- No trash can or recycling bin
- No bicycle facility along the bus route
- No bicycle racks or lockers
- No ADA compliant textured surfaces for wheelchair ramps at nearby intersections

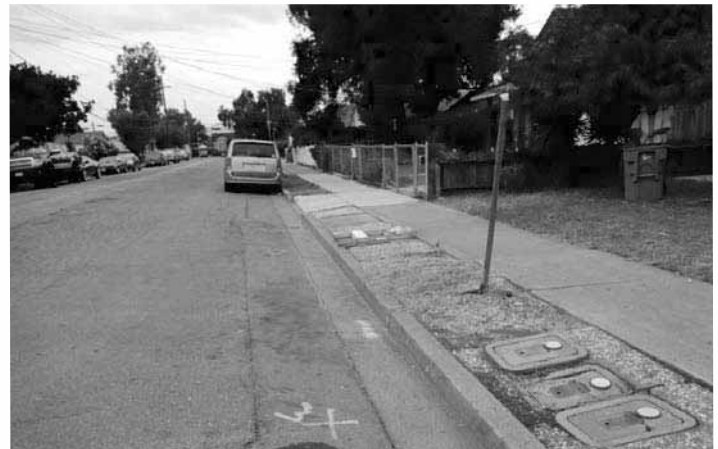
- Mid-block bus stop serving Red line in the southbound direction
- Existing signpost is slanted without any signage indicating the bus stop
- Curb at stop measures 32'0" but not painted red
- Adequate lighting in the street
- Sidewalk along bus stop measures 5'0"
- Bus stop location aligned with parking lane
- Several underground utility boxes within 100'0" of the bus stop
- Road surface near the bus stop need resurfacing
- Existing wheelchair ramps at nearby intersections
- Residential land uses around the bus stop

View of the bus stop

- No bus shelter or bench
- No trash can or recycling bin
- No bicycle facility along the bus route
- No bicycle lockers
- No system map, route map, or route timetable
- No ADA compliant textured surfaces for wheelchair ramps at upstream and downstream intersections
- No red curb painted

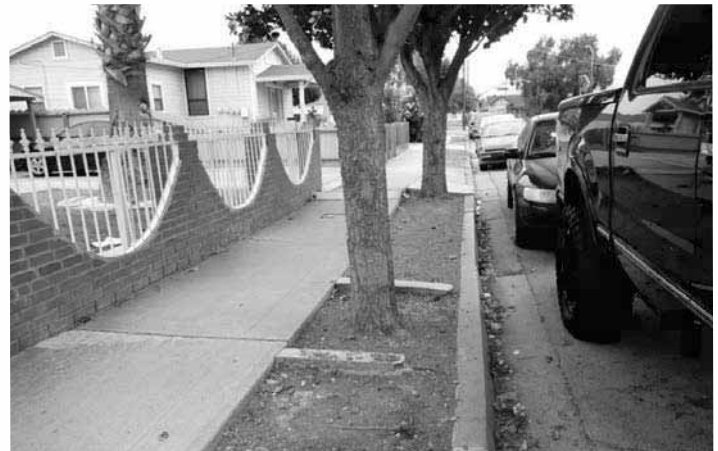
- Bus stop serving Red line in the northbound direction
- No signage indicating the bus stop
- Adequate lighting in the street
- Sidewalk along bus stop measures 5'10" but needs some resurfacing
- Red curb at stop measures 21'10"
- Access to the bus stop is not ADA friendly
- Residential land use around the bus stop
- Bus stop location aligned with parking lane
- Vehicles blocking access to the bus stop
- Debris around the bus stop
- Underground water meters and utility boxes within 100'0" of bus stop

Red curb at the bus stop without any signage

- No bus shelter or bench
- No bus stop signage
- No trash can or recycling bin
- No bicycle facility along the bus route
- No bicycle racks or lockers
- No system map, route map, or route timetable
- No ADA compliant textured surfaces for wheelchair ramps at upstream and downstream intersections
- "No Parking" sign and enforcement needed

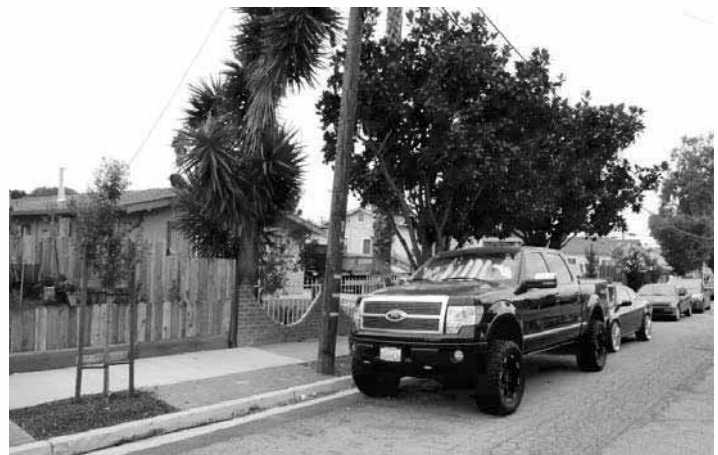
Vehicles blocking access to the bus stop

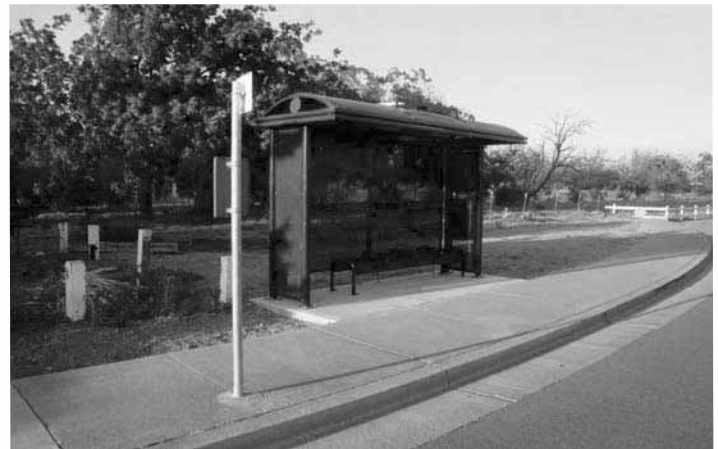
- One shelter measuring approximately 12' x 2'8"
- One bench measuring approximately 8' x 1'8" located inside the bus shelter
- Single bus stop serving both the Blue and Green lines
- Adequate signpost indicating bus stop
- Fixed signpost for route map and timetable
- Mid-block bus stop in residential area
- Trash can with lock attached to left side of shelter
- Solar powered lighting in the shelter
- Red curb: 39'0"
- Effective sidewalk width: 7'8"
- Residential land use around the bus stop
- Bus stop within travel lane
- Quality of road surface is good
- Wheelchair ramps provided at all corners of adjacent side streets, driveways, and crosswalks
- Textured surfaces present on both wheelchair ramps at upstream intersection
- Sidewalk ends after 80'0" on the left side
- Sidewalk connectivity issues east side of the bus stop

View of the bus stop

- No recycling bin
- No bicycle racks or lockers
- No bicycle facility along the bus route
- Deteriorating paint on the 39' red curb
- Upstream sidewalk has continuity issues
- No textured surfaces at wheelchair ramps at downstream intersection

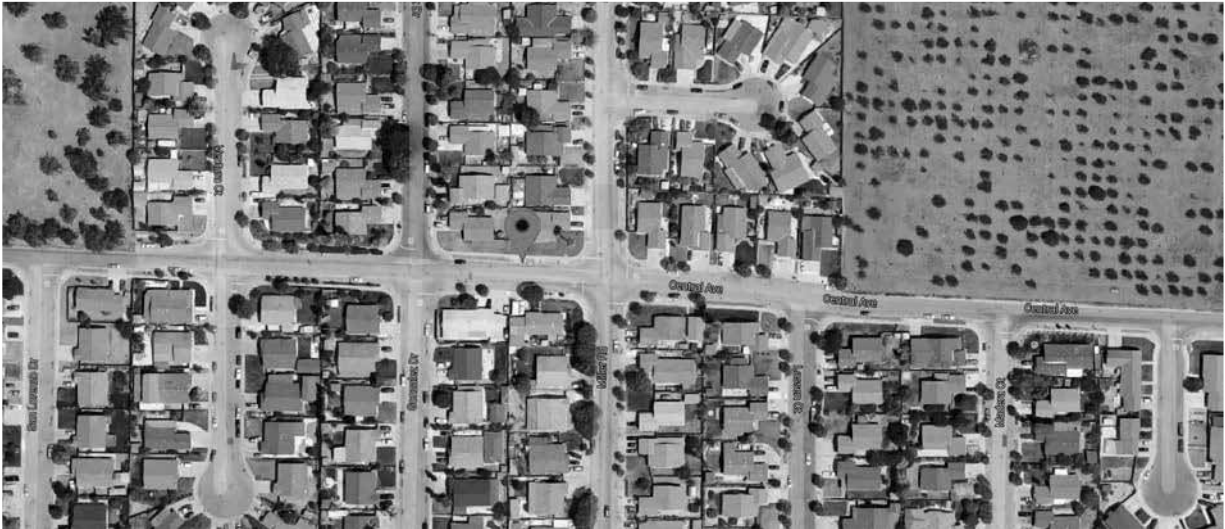
● ● #15

Aerial view of the bus stop

- No shelter
- No trash can or recycling bin
- No system map, route map, or route timetable
- No sign indicating bus stop
- No bicycle racks or lockers
- No bicycle facility along the bus route
- Deteriorating paint on the 38' red curb
- No textured surfaces at wheelchair ramps
- No shade for waiting passengers

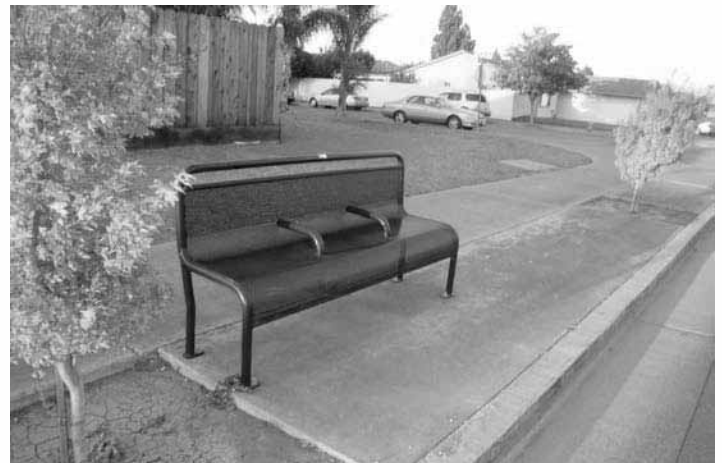
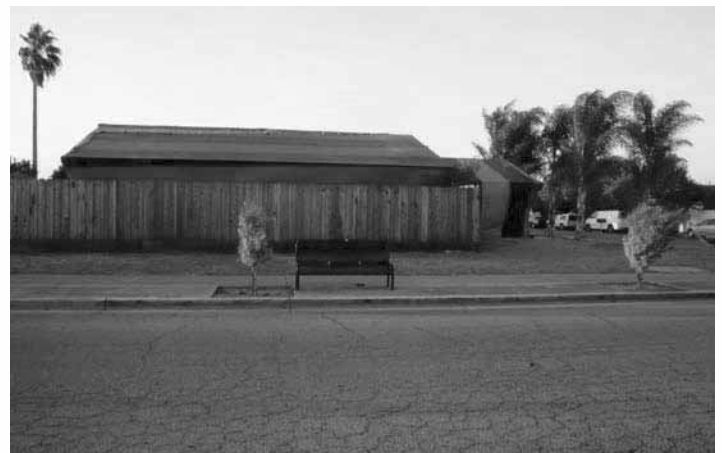
- Single bus stop serving both the Blue and Green lines
- One bench measuring approximately 6' x 1'10"
- Streetlight at the end of the block
- Red curb: 38'
- Effective sidewalk: 5'4"
- Near residential area
- Bus will stop within travel lane
- Quality of road surface/concrete bus pad is good
- Wheelchair ramps provided at all corners of adjacent side streets, driveways, and crosswalks
- Textured surfaces not present on both wheelchair ramps at intersection
- Continuous sidewalk providing access to the bus stop
- Residential land use around the bus stop

View of the bus stop

View of the bus stop from across the street

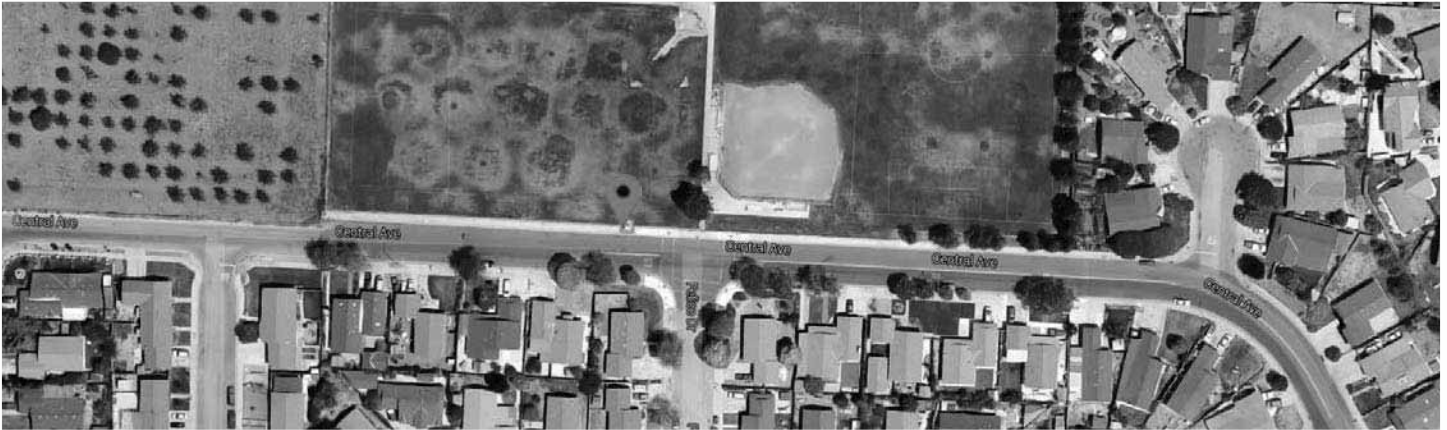
● ● #16

Top view of the bus stop

- No shelter or bench
- No trash can or recycling bin
- No system map, route map, or route timetable
- No bicycle racks or lockers
- No bicycle facility along the bus route
- Deteriorating paint on the 38'0" red curb
- No textured surfaces at all ramps at intersection
- Downstream sidewalk has continuity issues

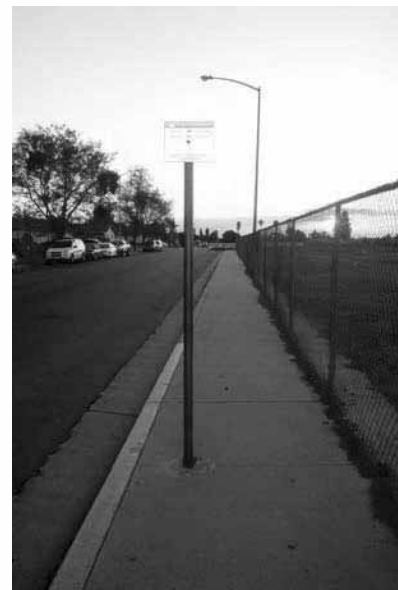
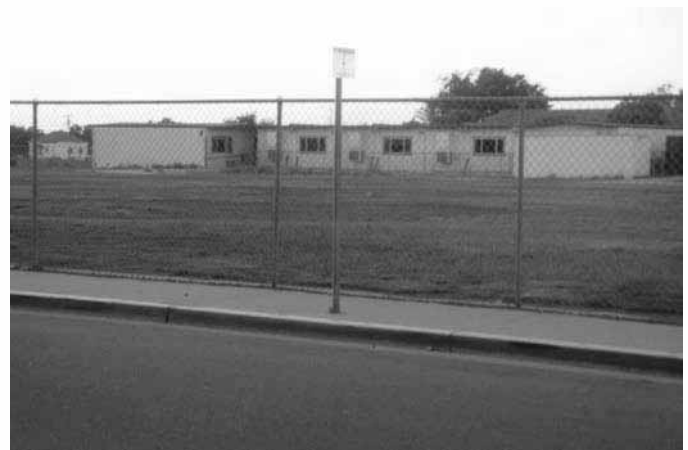
- Single bus stop serving both the Blue and Green lines
- Bus stop near a school
- Bus stop sometimes blocked by cars waiting to pickup students after school
- Adequate signpost indicating bus stop
- Streetlight at the end of the block
- Red curb: 38'0"
- Bus will stop within travel lane
- Quality of road surface/concrete bus pad is good
- Wheelchair ramps provided at all corners of adjacent side streets, driveways, and crosswalks
- Textured surfaces not present at all the ramps at intersection
- Sidewalk gets terminated 100'0" after the bus stop
- Residences around the bus stop

View of the bus stop

School buildings behind the bus stop

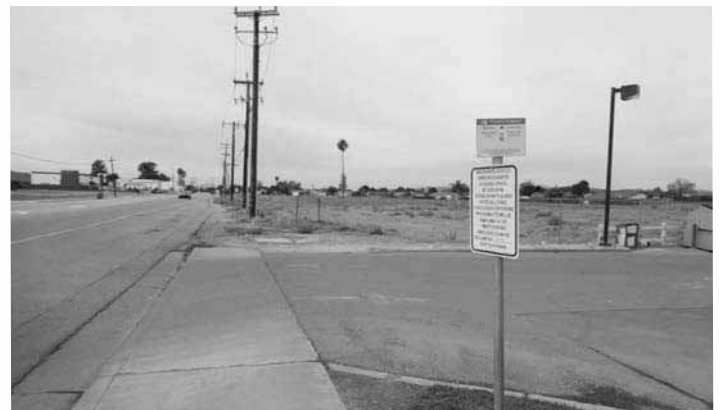
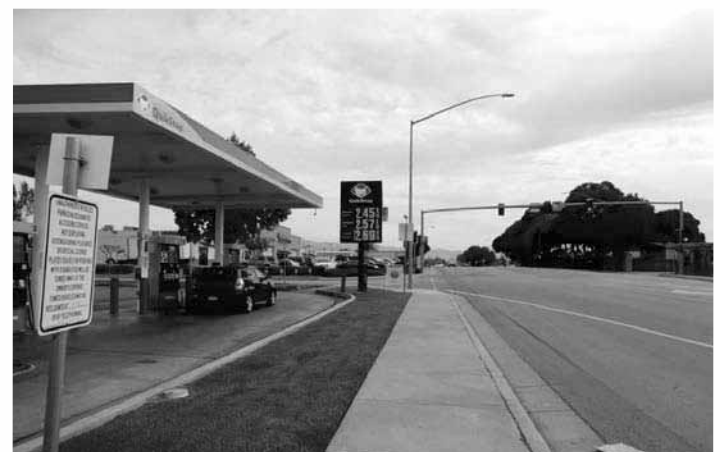
#17

- Bus stop serving the Inter-County bus line
- Signpost in good condition with route information
- Adequate lighting as the bus stop is near a gas station.
- Effective sidewalk: 6'0"
- 'No parking' sign downstream
- Class II bicycle facility along the bus route
- Bus stop has dedicated space
- Quality of road surface/concrete bus pad is good
- Bus stop is near commercial and residential areas
- This bus stop serves as Inter-County bus stop providing service to Gilroy and San Juan Bautista
- Wheelchair ramps provided at all corners of adjacent side streets, driveways, and crosswalks
- Sidewalk terminates near the gas station and there is no sidewalk by the empty lot across the street

View of the bus stop showing terminated sidewalk

- No shelter or bench
- No trash can or recycling bin
- No route map or schedule
- No bicycle racks or lockers
- Bike lane terminates at the bus stop
- No textured surfaces at ramps at downstream intersection
- No sidewalk on the street across the bus stop
- Sidewalk has continuity issues

View of the bus stop showing the marked bus bay

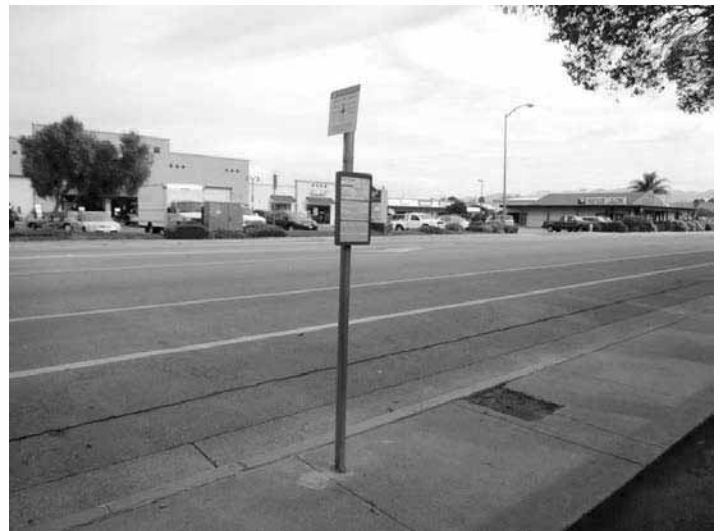
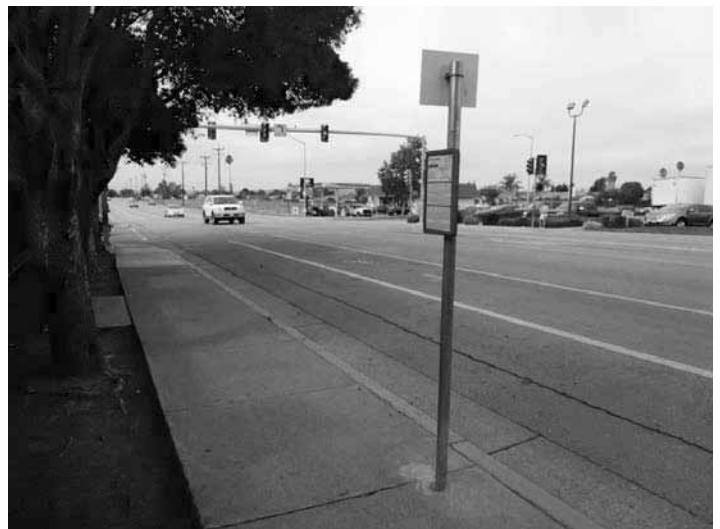
● ● #18

- Bus stop serving the Green and Blue lines
- Adequate signpost indicating bus stop
- Fixed signpost for route map and timetable in good condition
- Red curb measuring approximately 75'0" needs painting
- Effective sidewalk width is 6'0"
- Class II bicycle facility along the bus route
- Bus will stop aligned with curb/parking lane
- Quality of road surface/concrete bus pad is good
- Bus stop near a commercial and residential area
- This bus stop serves Inter-County bus line
- Continuous sidewalk terminates 120'0" upstream from the bus stop
- Wheelchair ramps provided at all corners of adjacent side streets, driveways, and crosswalks
- Bus stop just outside a residential community

View of the bus stop

- No shelter or bench
- No trash can or recycling bin
- Streetlight is covered by tree
- Deteriorating paint on the 75'0" red curb
- No bicycle racks or lockers
- Bicycle lane needs markings
- Wheelchair ramps are missing ADA compliant textured surfaces

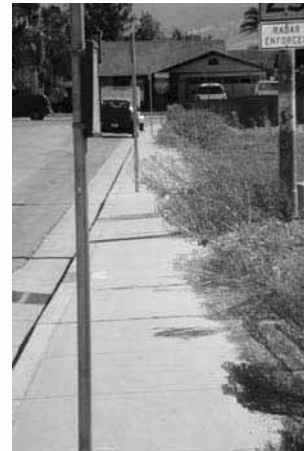
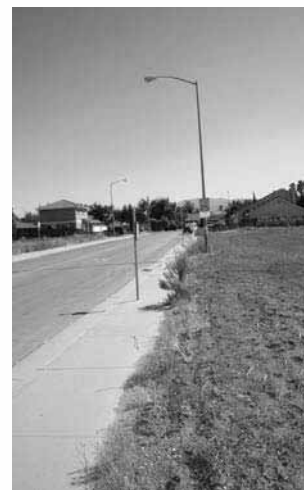
#19

- Bus stop serving the Blue line
- Adequate signpost indicating bus stop
- Effective sidewalk: 3'3"
- No shade or seating for waiting passengers
- Streetlight near bus stop
- Bus stop in between a residential and commercial neighborhoods but surrounded by empty lots
- Red curb measuring approximately 76'0" has deteriorating paint
- No parking signs in both directions
- Quality of road surface/concrete bus pad is good
- Bus will stop within travel lane
- Wheelchair ramps provided at all corners of adjacent side streets, driveways, and crosswalks
- Continuous sidewalk
- Shrubs and foliage obstructing the sidewalk

View of the bus stop

- No shelter or bench
- No trash can or recycling bin
- Fixed signpost for route map and timetable appears vandalized
- Signpost indicating bus stop is missing route information
- Deteriorating paint on the 76'0" red curb
- No bicycle facility along the bus route
- No textured surfaces at wheelchair ramps at intersections
- Deteriorated sidewalk
- No bicycle racks or lockers

View of the bus stop from across the street

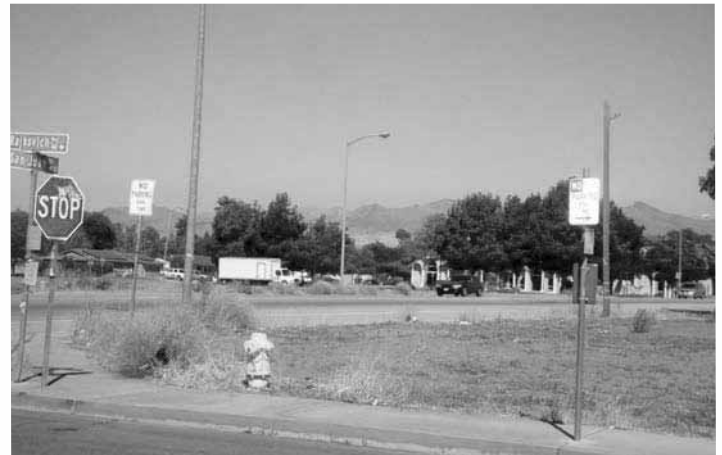
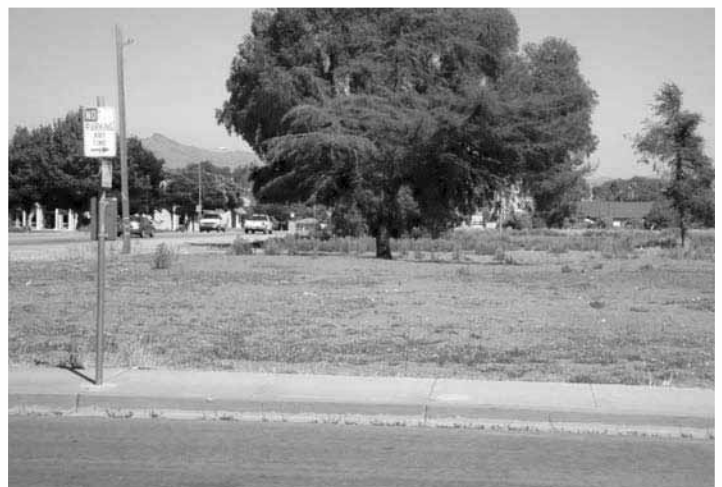
#20

- Adequate signpost indicating bus stop
- Effective sidewalk: 3'3"
- Streetlight near bus stop
- Bus stop in commercial area
- Red curb: 76'0"
- Quality of road surface is good
- No parking in both direction
- Bus will stop within travel lane
- Wheelchair ramps provided at all corners of adjacent side streets, driveways, and crosswalks
- Continuous sidewalk
- Shrubs and foliage obstructing the sidewalk

View of the bus stop

- No shelter or bench
- No trash can or recycling bin
- Fixed signpost for route map and timetable appears vandalized
- Deteriorating paint on the 76'0" red curb
- No bicycle facility along the bus route
- No textured surfaces at wheelchair ramps at intersections
- Deteriorated sidewalk
- No bicycle racks or lockers

View of the bus stop from across the street

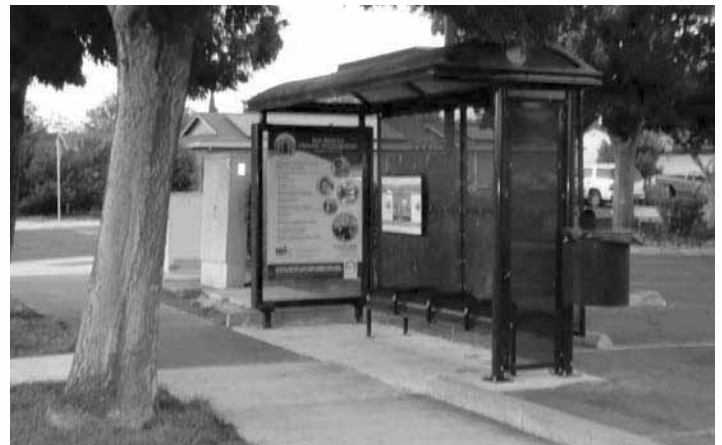
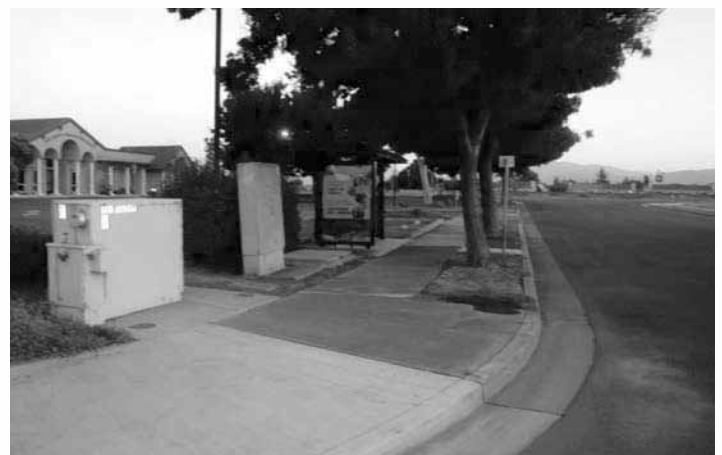
● ● #21

- Single bus stop serving both the Blue and Green bus lines
- One shelter: 12' x 4'7"
- One interior bench: 8' x 1'8"
- Adequate signpost indicating bus stop
- Fixed signpost for route map and timetable
- Trash can attached to left side of shelter
- Solar powered lighting in the shelter
- Red curb: 60'0"
- Effective sidewalk: 6'0"
- Near hospital
- Bus will stop within travel lane
- Utility boxes near the bus stop area
- Quality of road surface is good
- Wheelchair ramps provided at all corners of adjacent side streets, driveways, and crosswalks
- Textured surfaces present on all wheelchair ramps at intersection
- Continuous sidewalk

View of the bus shelter

- No recycling bin
- No bicycle racks or lockers
- No bicycle facility along the bus route
- Deteriorating paint on the 60'0" red curb
- Sidewalk across the bus needs cleaning and resurfacing

View of the bus shelter from across the street

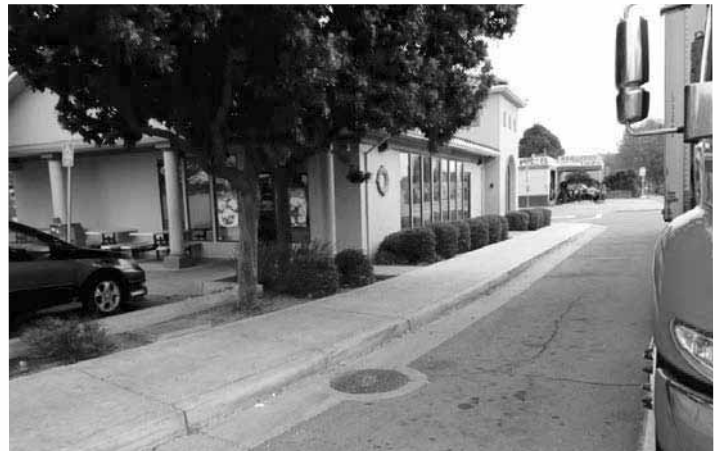
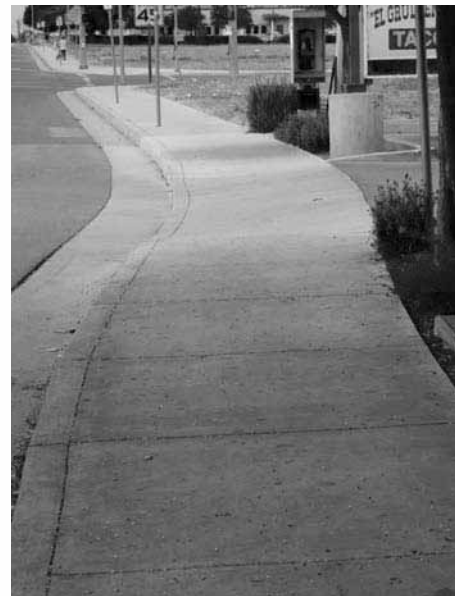
#22

- Bus stop serving the Blue line
- No signage indicating the bus stop
- Adequate lighting in the street
- Sidewalk along bus stop measures 5'0"
- Red curb at stop measures 78'0"
- Wheelchair ramps at all corners of the nearby intersections
- "No Parking" sign found on downstream
- Residences and restaurant near the bus stop
- Bus stop location has a striped area which could be designated as a pullout lane for buses

View of the unmarked bus stop

- No bus shelter or bench
- No bus stop signage
- No system map, route map, or route timetable
- No system map, route map, or route timetable
- No trash can or recycling bin
- No bicycle facility along the bus route
- No bicycle racks or lockers
- No ADA compliant textured surfaces for wheelchair ramps at the nearby intersection
- Limited space for shelter and bench

Vehicles blocking access to the bus stop

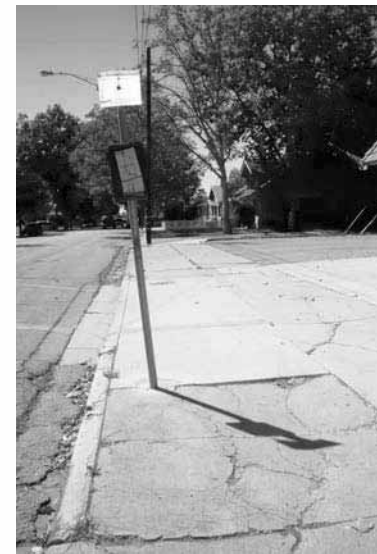
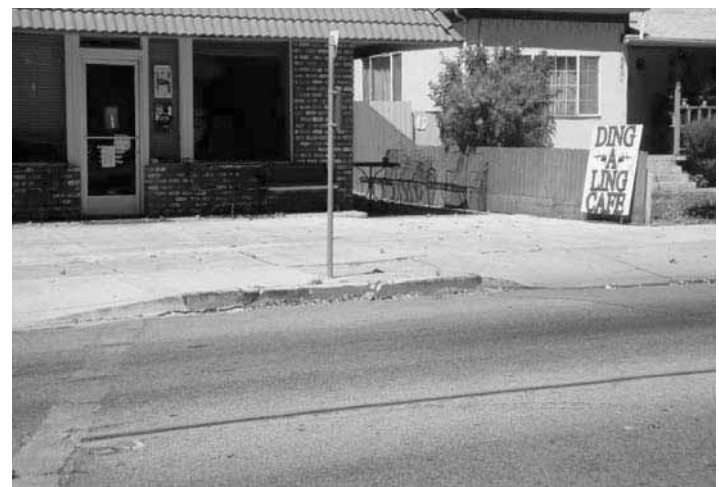
#23

- Bus stop serving the Blue bus line
- Signpost indicating bus stop fixed on a cracked pavement creating a hazard
- Fixed signpost with the route map and timetable is slanted
- Effective sidewalk: 5'8"
- Streetlight near bus stop
- Bus stop in residential area
- Red curb: 11'8"
- Bus will stop within the travel lane
- Wheelchair ramps provided at all corners of adjacent side streets, driveways, and crosswalks
- Continuous sidewalk
- Not enough space for the bus stop as it is blocking a driveway
- Vehicles traveling on the corridor at high speeds
- Bus stop not in an ideal location

View of the bus stop showing deteriorating sidewalk

- Pavement by the bus stop needs repairs
- Fixed signpost for route map and timetable appears vandalized and needs replacement
- No shelter or bench
- No trash can or recycling bin
- Red curb needs reconstruction
- No bicycle facility along the bus route
- No textured surfaces at wheelchair ramps at upstream and downstream intersections
- Quality of road surface/concrete bus pad is not good
- No bicycle racks or lockers

View of the bus stop from across the street
