**AGENDA
REGULAR MEETING
LOCAL TRANSPORTATION AUTHORITY**

5. **RECEIVE** Presentation on the San Benito County Local Transportation Authority's Bus Stop Improvement Plan (BSIP) and **ACCEPT** the Final Report – Gilbert

The San Benito County Local Transportation Authority (LTA) Bus Stop Improvement Plan is a planning document that summarizes findings and details results and recommendations of the County Express Bus Stop Improvement Project. The objectives of the project was aimed to evaluate existing conditions of the bus stops operated by the LTA, incorporate input from the public with the findings, provide recommendations for improvements, costs estimates, and conceptual design, and prioritize bus stops for improvements. The key tasks of the project include the following:

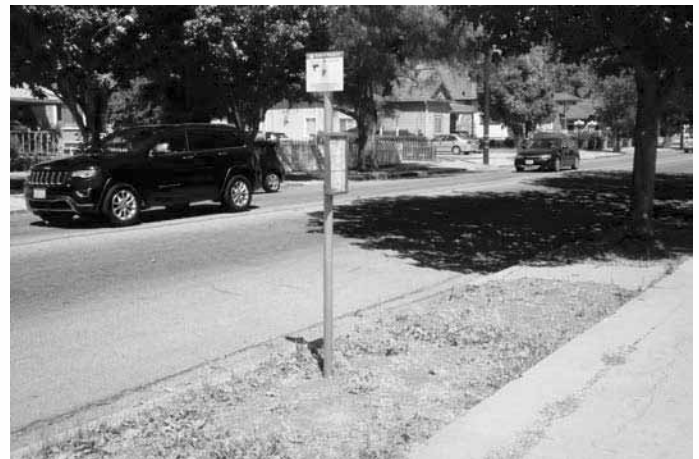
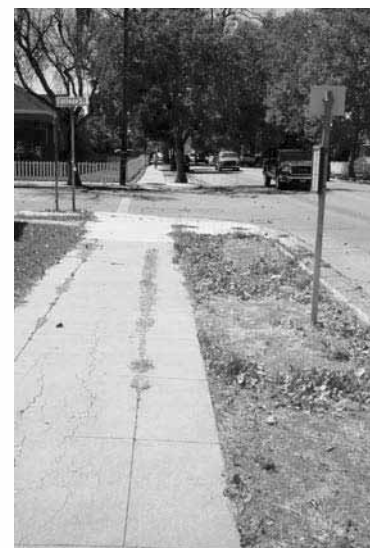
#24

- Bus stop serving the Green bus line
- Adequate signpost indicating bus stop
- Effective sidewalk: 5'8"
- Sidewalk pavement doesn't extend up to the curb
- Streetlight near bus stop
- Bus stop in commercial area
- Red curb: 32'6"
- Bus will stop within travel lane
- Quality of road surface/concrete bus pad is good
- Wheelchair ramps provided at all corners of adjacent side streets, driveways, and crosswalks
- Continuous sidewalk
- Bus stop is not easily accessible by wheelchairs

View of the bus stop

- No shelter or bench
- No trash can or recycling bin
- Fixed signpost for route map and timetable appears vandalized
- Deteriorating paint on the red curb
- Deteriorated sidewalk needs repairs
- Not adequate lighting in bus stop
- No bicycle facility along the bus route
- No textured surfaces at wheelchair ramps at downstream intersections
- No bicycle racks or lockers

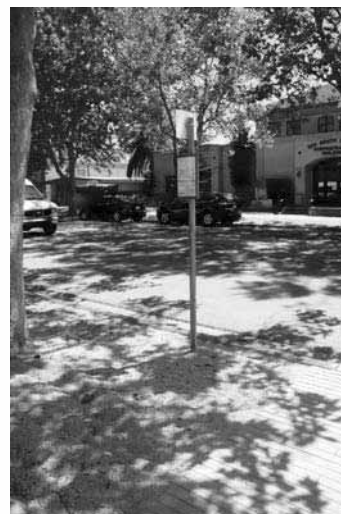
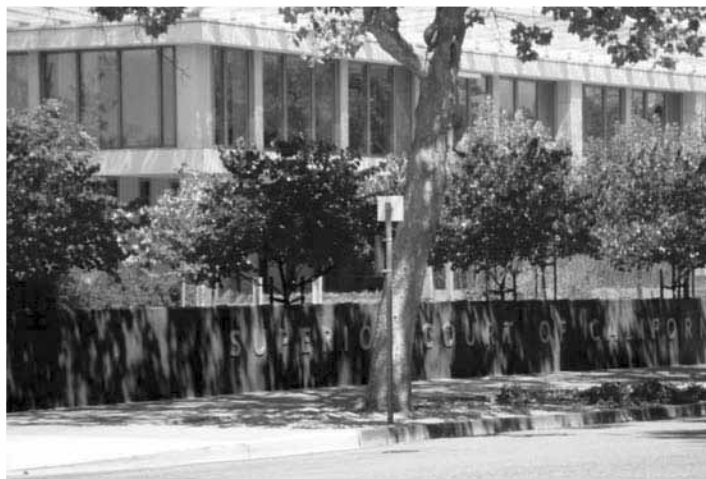
#25

- Bus stop serving the Blue bus line outside the San Benito Superior Court building
- Adequate signpost indicating bus stop
- Fixed signpost for route map and timetable
- Utility boxes near the bus stop area
- Effective sidewalk: 9'0"
- No parking in both direction
- Streetlight nearby and lamppost near bus stop
- Bus stop in commercial area
- Red curb: 6'0"
- Bus will stop aligned with curb/parking lane
- Quality of road surface/concrete bus pad is good
- Wheelchair ramps provided at all corners of adjacent side streets, driveways, and crosswalks
- Continuous sidewalk

View of the bus stop

- No shelter or bench
- No trash can or recycling bin
- No bicycle facility along the bus route
- No bike racks or lockers
- Deteriorating paint on the 60'0" red curb
- No textured surfaces at wheelchair ramps at upstream intersections

View of the bus stop from across the street

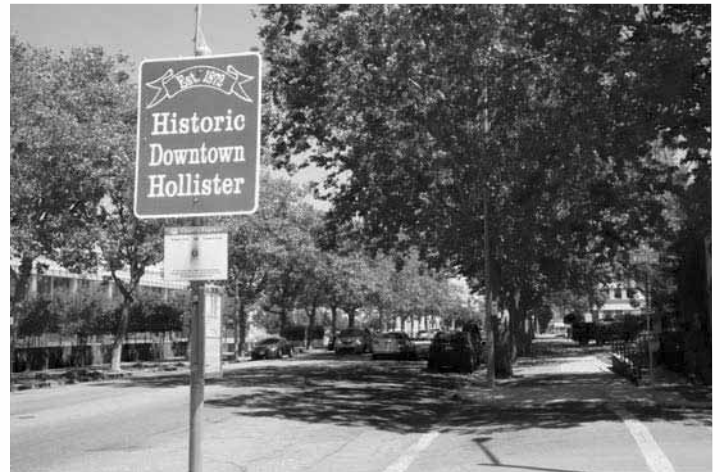
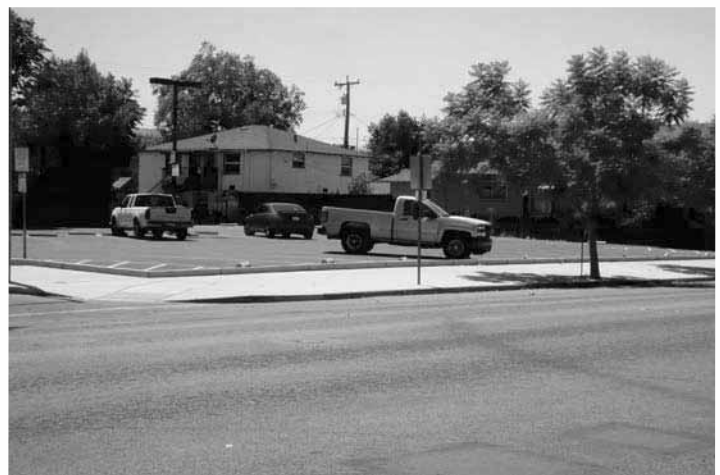
#26

- Bus stop serving the Green bus line near the San Benito Superior Court building
- Adequate signpost indicating bus stop
- Fixed signpost for route map and timetable
- Effective sidewalk: 10'2"
- Streetlight near bus stop
- Bus stop in commercial area
- Red curb: 30'0"
- Bus will stop aligned with curb/parking lane
- Quality of road surface/concrete bus pad is good
- Wheelchair ramps provided at all corners of adjacent side streets, driveways, and crosswalks
- Continuous sidewalk

View of the Bus Stop

- No shelter or bench
- No trash can or recycling bin
- No bicycle facility along the bus route
- No textured surfaces at wheelchair ramps at downstream intersections
- No bicycle racks or lockers

View of the Bus Stop from across the Street

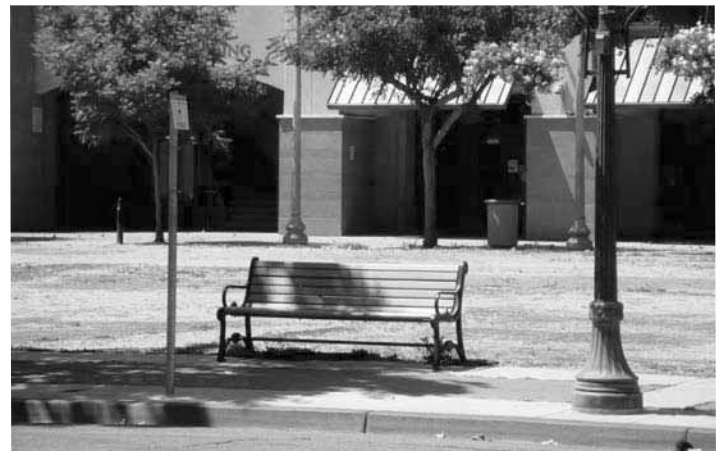
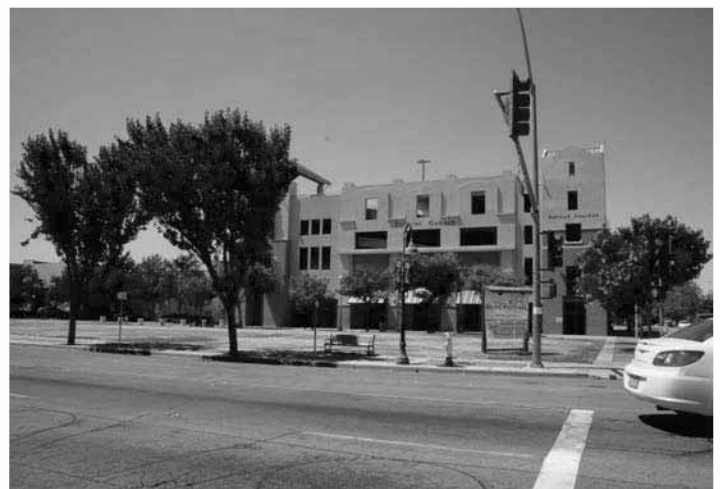
#27

- Bus stop currently serves the Red line in the southbound direction
- One bench: 6' x 2'4"
- Adequate signpost indicating bus stop
- Fixed signpost for route map and timetable
- Effective sidewalk: 6'8"
- Streetlight near bus stop
- Bus stop in commercial area
- Trash can and recycle bin located mid-block away from the bus stop
- Red curb: 47'0"
- Bus will stop aligned with curb/parking lane
- Quality of road surface/concrete bus pad is good
- Utility boxes near the bus stop area
- Wheelchair ramps provided at all corners of adjacent side streets, driveways, and crosswalks
- Continuous sidewalk

View of the Bus Stop

- No shelter
- Signpost indicating bus stop does not have route information
- No bicycle facility along the bus route
- No bicycle racks or lockers
- Deteriorating paint on the 47'0" red curb
- No textured surfaces at wheelchair ramps at all intersections

View of the Bus Stop from across the Street

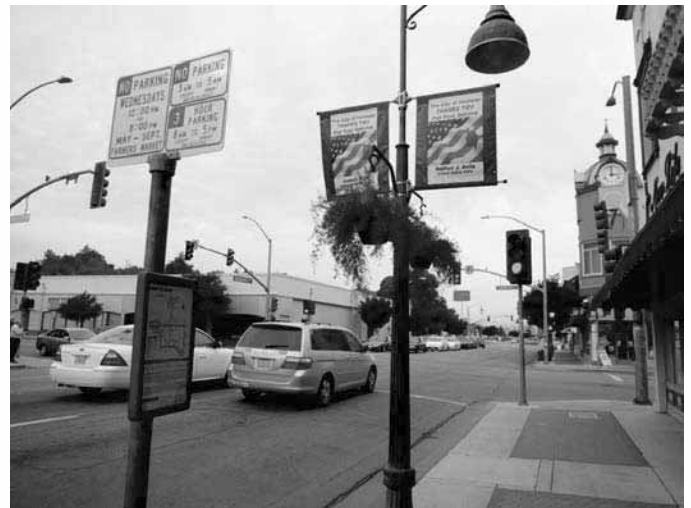
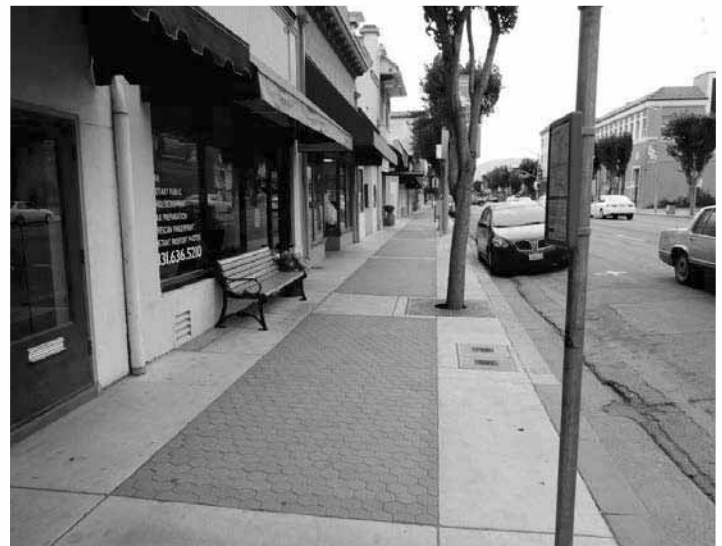
#28

- Bus stop currently serves the Red line in the northbound direction
- One bench: 6' x 2'4"
- Adequate signpost indicating bus stop
- Fixed signpost for route map and timetable
- Effective sidewalk: 6'8"
- Streetlight near bus stop
- Bus stop in commercial area
- Trash can and recycle bin located mid-block away from the bus stop
- Red curb: 47'0"
- Bus will stop aligned with curb/parking lane
- Quality of road surface/concrete bus pad is good
- Utility boxes near the bus stop area
- Wheelchair ramps provided at all corners of adjacent side streets, driveways, and crosswalks
- Continuous sidewalk

View of the bus stop

- No shelter
- Signpost indicating bus stop does not have route information
- No bicycle facility along the bus route
- No bicycle racks or lockers
- Deteriorating paint on the 47'0" red curb
- No textured surfaces at wheelchair ramps at all intersections

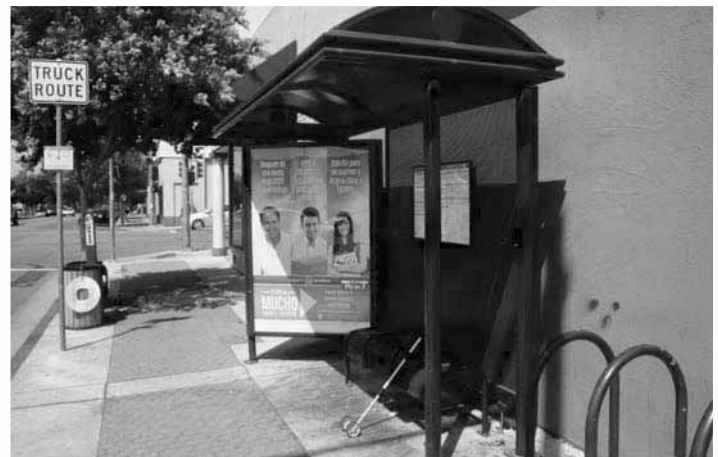
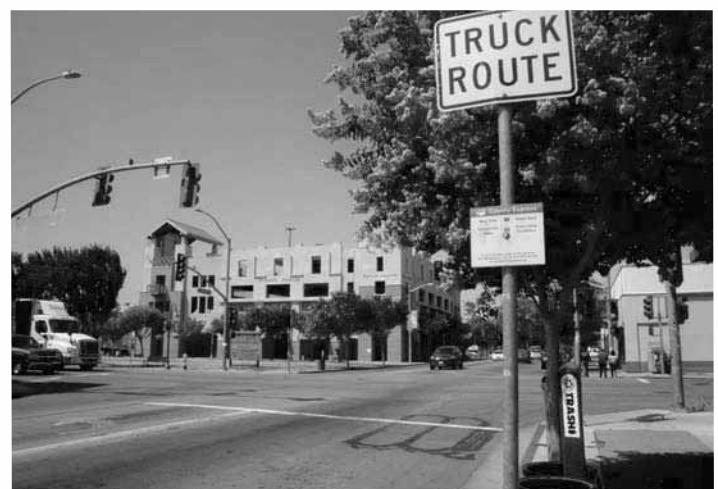
● ● #29

- Bus stop serving the Blue line and the Inter-County bus lines
- One shelter: 12' x 4'0"
- One interior bench: 5' x 1'8"
- Adequate signpost indicating bus stop
- Fixed signpost indicating the routes served
- The route map, timetable, including the Inter-County route map inside the shelter
- Bus stop in downtown area
- Parking restrictions on both side, 3-hour limit
- Bicycle rack: vertical "U" poles for three bicycles
- Trash can and recycle bin attached to right side of shelter
- Streetlight near bus stop
- Red curb: 92'6"
- Effective sidewalk: 7'0"
- Bus will stop aligned with curb/parking lane
- Quality of road surface/concrete bus pad is good
- Wheelchair ramps provided at all corners of adjacent side streets, driveways, and crosswalks

View of the Bus Stop

View of the Bus Stop from across the Street

- No bicycle facility along the bus route
- Deteriorating paint on the 92'6" red curb
- No textured surfaces at wheelchair ramps at all intersections
- Tree branches up to 3'0" from ground covering sidewalk
- No open space for wheelchair inside the shelter
- Deteriorating paint on bicycle racks

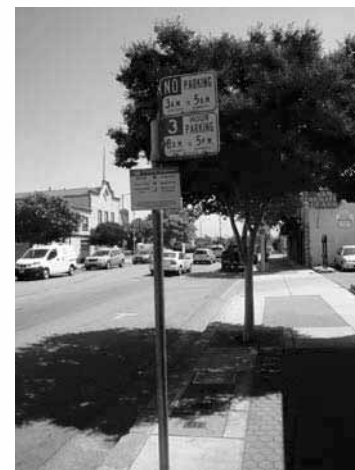
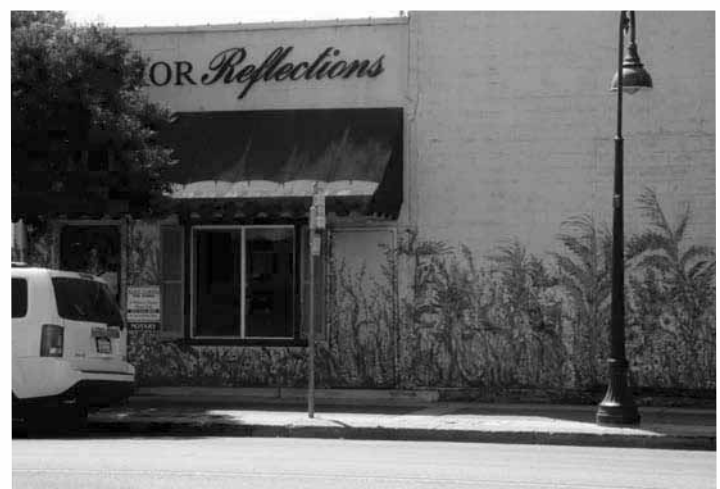
- Bus stop currently serves the Green line
- Streetlight nearby and lamppost near bus stop
- Adequate signpost indicating bus stop
- Lack of red curb encourages vehicle parking in this prime downtown location
- Utility boxes near the bus stop area
- Effective sidewalk: 8'0"
- Bus will stop within travel lane
- Quality of road surface/concrete bus pad is good
- Bus stop is near commercial area
- Wheelchair ramps provided at all corners of adjacent side streets, driveways, and crosswalks
- Continuous sidewalk

View of the bus stop

- No shelter or bench
- No bicycle facility along the bus route
- No red curb
- No textured surfaces at wheelchair ramps at all intersections
- No bicycle racks or lockers
- No ADA compliant textured surfaces at ramps

View of the bus stop from across the street

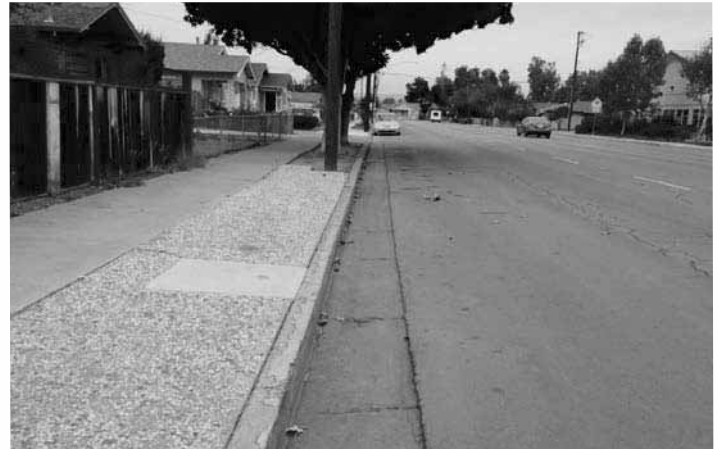
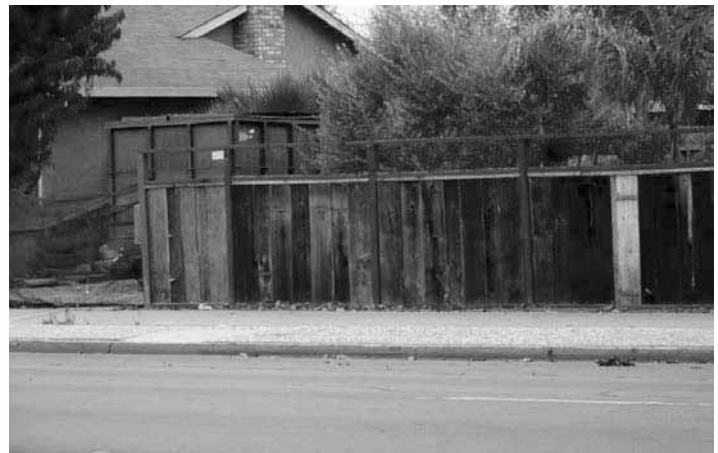
● #31

- No signpost
- No system map, route map, or route timetable
- No bus shelters
- No recycling bin
- No red curb
- No bicycle facility along the bus route
- No bicycle lockers

View of the Bus Stop

View of the Bus Stop from Across the Street

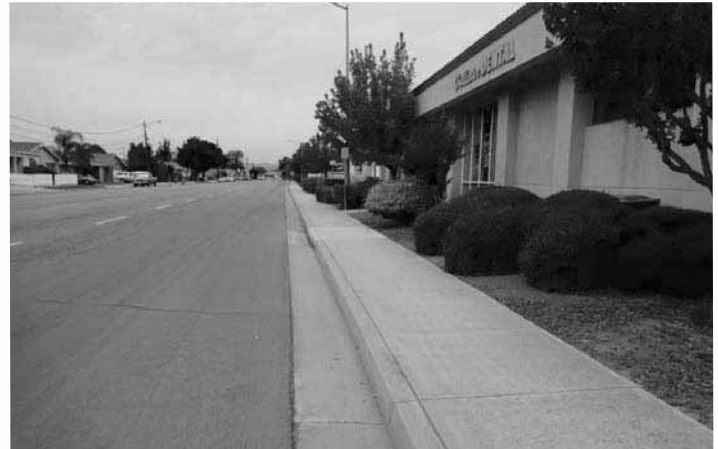
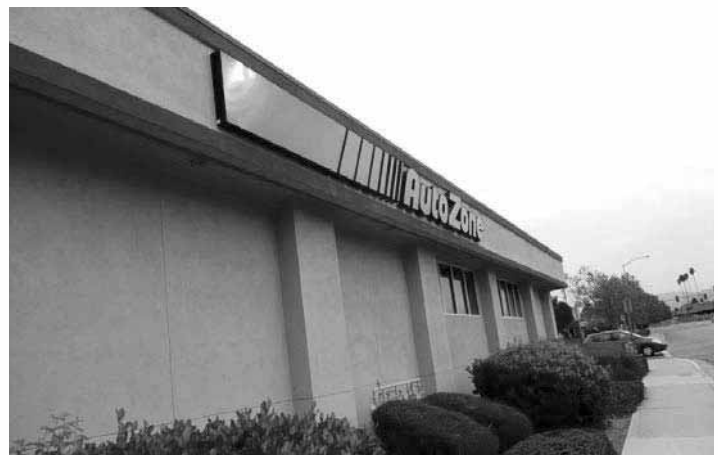
#32

- No signpost
- No system map, route map, or route timetable
- No bus shelters
- No recycling bin
- No red curb at the bus stop
- No bicycle facility along the bus route
- No bicycle lockers

View of the Bus Stop

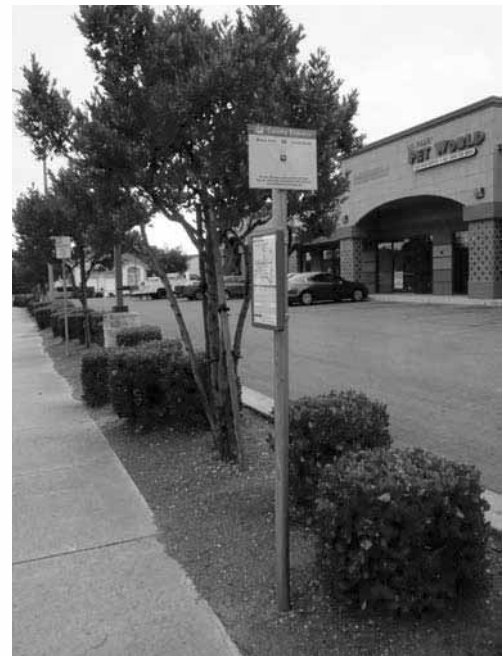
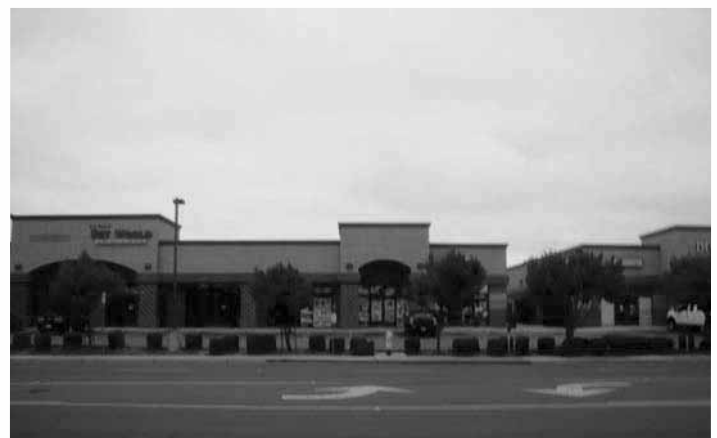
#33

- Bus stop currently serves the Green bus line
- Adequate signpost indicating bus stop
- Fixed signpost for route map and timetable
- No parking in both direction
- Fire hydrant near bus stop
- Streetlight nearby and lamppost near bus stop
- Red curb: 35'0"
- Continuous sidewalk
- No parking in downstream direction
- Bus will stop within travel lane
- Effective sidewalk: 5'0"
- Quality of road surface/concrete bus pad is good
- Bus stop is near commercial area
- Wheelchair ramps provided at all corners of adjacent side streets, driveways, and crosswalks
- Textured surfaces present at all the ramps at intersection

View of the bus stop

- No shelter or bench
- No trash can or recycling bin
- Deteriorating paint on the 35'0" red curb
- Narrow sidewalk
- No bicycle racks or lockers
- No bicycle facility along the bus route

View of the bus stop from across the street

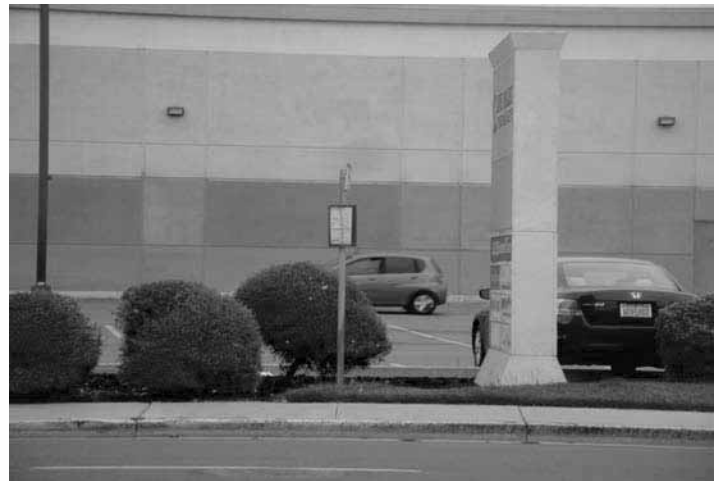
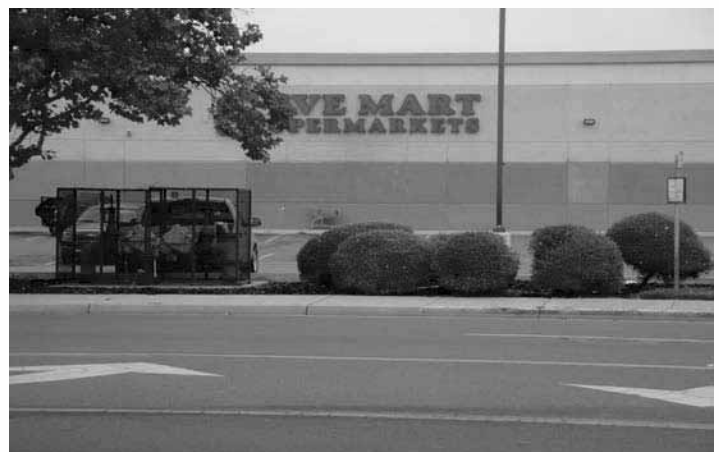
#34

- Adequate signpost indicating bus stop
- Streetlight nearby
- Red curb: 35'2"
- Utility boxes near the bus stop area
- Continuous sidewalk
- No parking in downstream direction
- Bus will stop within travel lane
- Effective sidewalk: 5'0"
- Quality of road surface/concrete bus pad is good
- Bus stop is near commercial area
- Wheelchair ramps provided at all corners of adjacent side streets, driveways, and crosswalks
- Textured surfaces present at all the ramps at intersection

View of the bus stop

- No shelter or bench
- No trash can or recycling bin
- Deteriorating paint on the 35'2" red curb
- Fixed signpost for route map and timetable appears vandalized
- Narrow sidewalk
- No bicycle racks or lockers
- No bicycle facility along the bus route

View of the bus stop from across the street

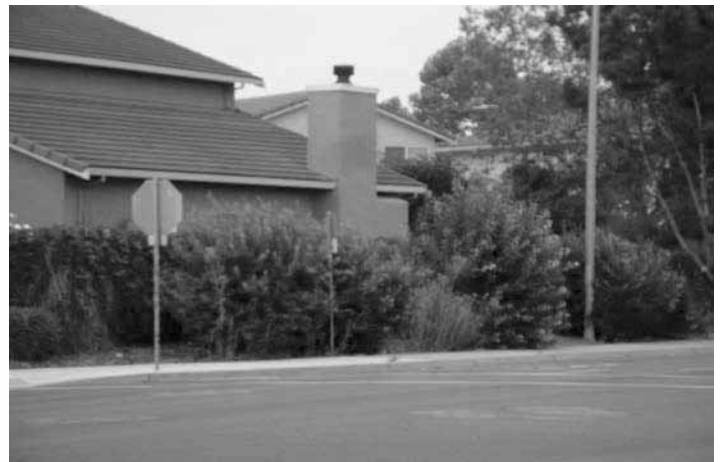
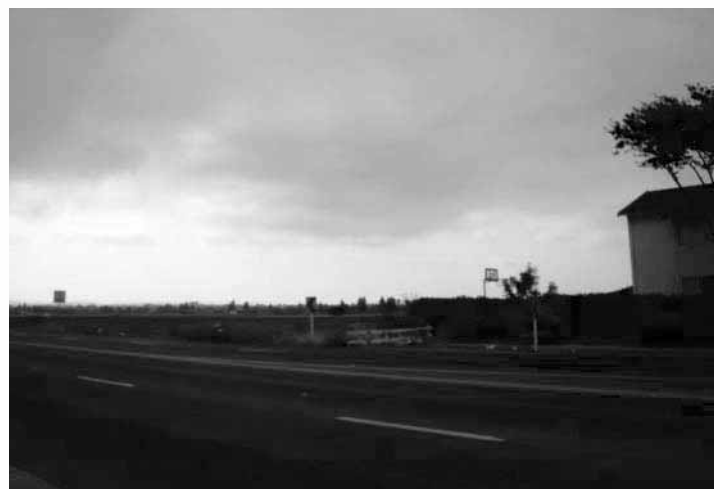
#35

- Bus stop currently serves the Green line
- Adequate signpost indicating bus stop
- Fixed signpost for route map and timetable
- Streetlight nearby
- No parking in both direction
- Utility box near the bus stop area
- Bus will stop within travel lane
- Effective sidewalk: 5'0"
- Quality of road surface/concrete bus pad is good
- Bus stop is near residential area
- Sidewalk gets terminated 180'0" after the bus stop
- Wheelchair ramps provided at all corners of adjacent side streets, driveways, and crosswalks
- Textured surfaces present at all the ramps at intersection

View of the bus stop

- No shelter or bench
- No trash can or recycling bin
- No red curb
- Narrow sidewalk
- Sidewalk has continuity issues
- No bicycle racks or lockers
- No bicycle facility along the bus route
- Bus stop is covered in bushes

View of Meridian Street; narrows past the intersection

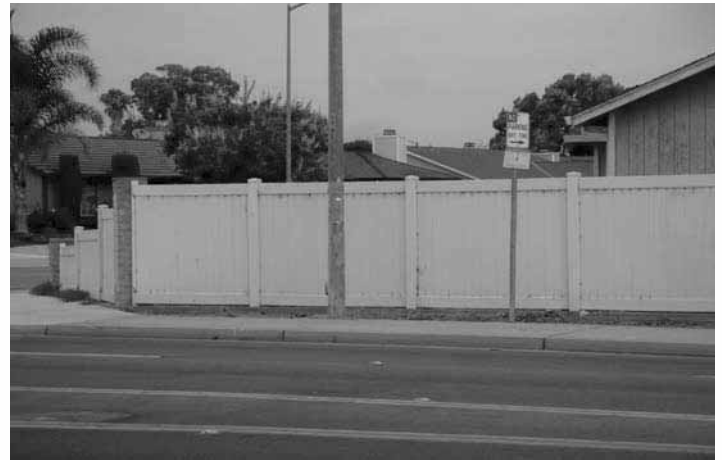
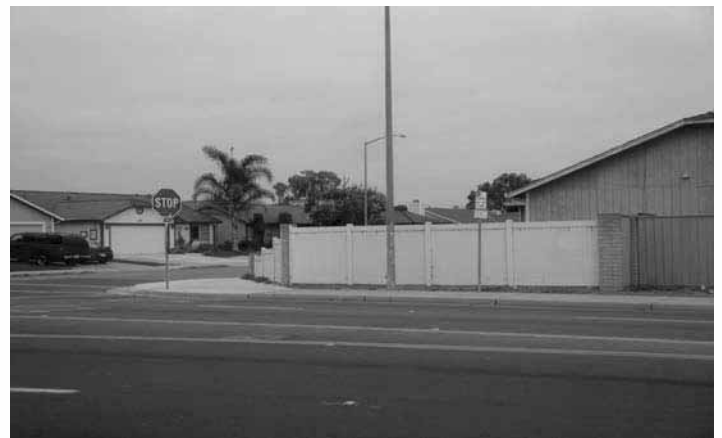
#36

- Bus stop currently serves the Blue line
- Adequate signpost indicating bus stop
- Fixed signpost for route map and timetable
- Streetlight nearby
- Continuous sidewalk
- No parking in both direction
- Bus will stop within travel lane
- Effective sidewalk: 5'0"
- Quality of road surface/concrete bus pad is good
- Bus stop is near residential area
- Wheelchair ramps provided at all corners of adjacent side streets, driveways, and crosswalks
- Textured surfaces present at all the ramps at intersection

View of the bus stop

- No shelter or bench
- No trash can or recycling bin
- No red curb
- Narrow sidewalk
- No bicycle racks or lockers
- No bicycle facility along the bus route

View of the bus stop from across the street

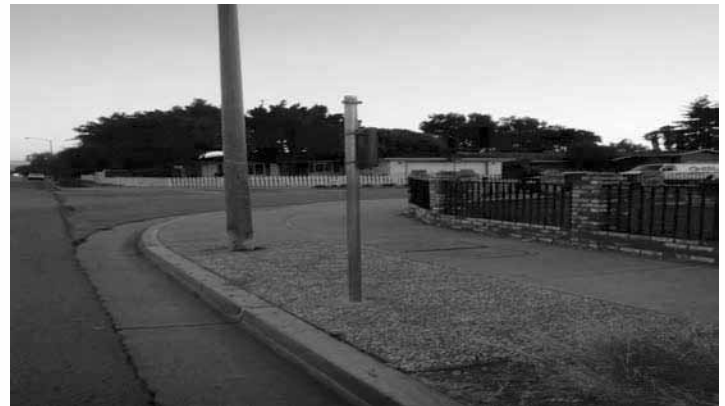
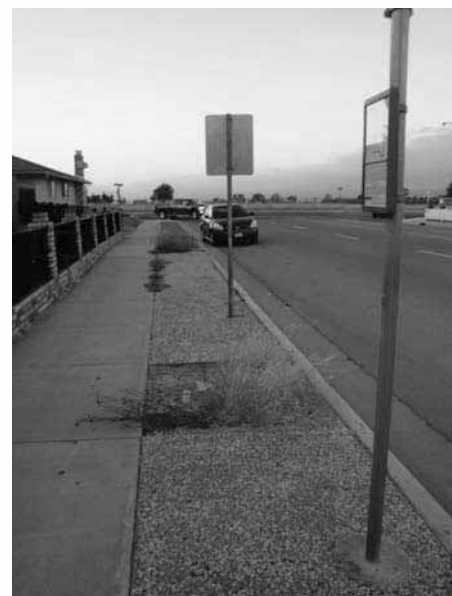
#37

- Bus stop currently serves the Green line
- Adequate signpost indicating bus stop
- Fixed signpost for route map and timetable
- Effective sidewalk: 9'6"
- Streetlight near bus stop
- Bus stop in residential area
- Red curb: 50'0"
- Quality of road surface/concrete bus pad is good
- Bus will stop aligned with curb/parking lane
- Continuous sidewalk
- Wheelchair ramps provided at all corners of adjacent side streets, driveways, and crosswalks

View of the bus stop

- No shelter or bench
- No trash can or recycling bin
- Sidewalk plants need trimming
- Deteriorating paint on the 50'0" red curb
- No bicycle facility along the bus route
- No bicycle racks or lockers
- No textured surfaces at wheelchair ramps at intersections

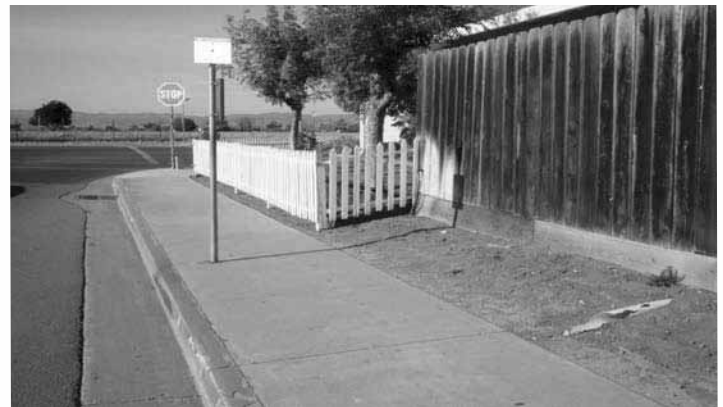
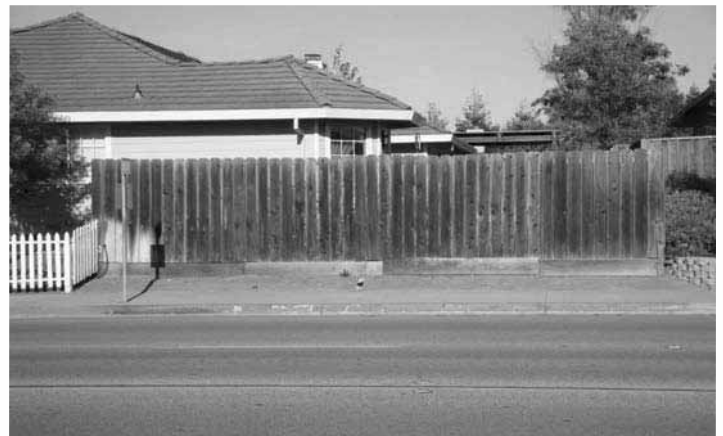
● #38

- Bus stop currently serves the Blue line
- Adequate signpost indicating bus stop
- Fixed signpost for route map and timetable
- Effective sidewalk: 3'8"
- Streetlight near bus stop
- Bus stop in residential area
- Red curb: 50'0"
- Quality of road surface/concrete bus pad is good
- Bus will stop aligned with curb/parking lane
- Continuous sidewalk
- Wheelchair ramps provided at all corners of adjacent side streets, driveways, and crosswalks
- Textured surfaces at wheelchair ramps at intersections

View of the bus stop

- No shelter or bench
- No trash can or recycling bin
- Sidewalk plants need trimming
- Deteriorating paint on the 50'0" red curb
- No bicycle facility along the bus route
- No bicycle racks or lockers
- Drainage leak needs to be fixed

View of the bus stop from across the street

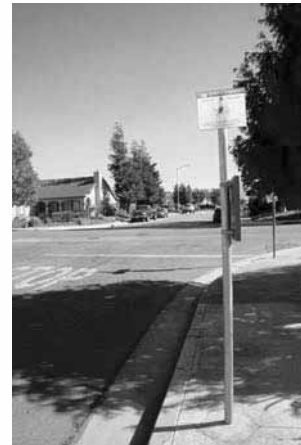
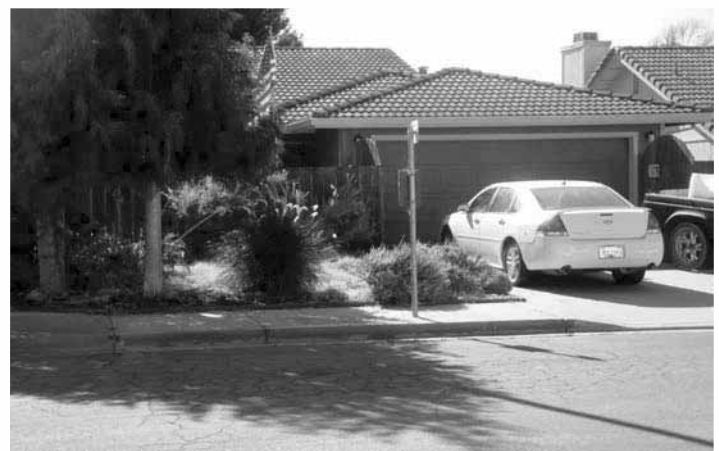
#39

- Bus stop currently serves the Blue line
- Adequate signpost indicating bus stop
- Effective sidewalk: 3'9"
- Streetlight near bus stop
- Bus stop in residential area
- Red curb: 15'6"
- No parking in both direction
- Quality of road surface/concrete bus pad is good
- Bus will stop aligned with curb/parking lane
- Wheelchair ramps provided at all corners of adjacent side streets, driveways, and crosswalks
- Textured surfaces present at all the ramps at intersection
- Continuous sidewalk

View of the bus stop

- No shelter or bench
- No trash can or recycling bin
- Fixed signpost for route map and timetable appears vandalized
- Deteriorating paint on the 15'6" red curb
- No bicycle facility along the bus route
- No bicycle racks or lockers

View of the bus stop from across the street

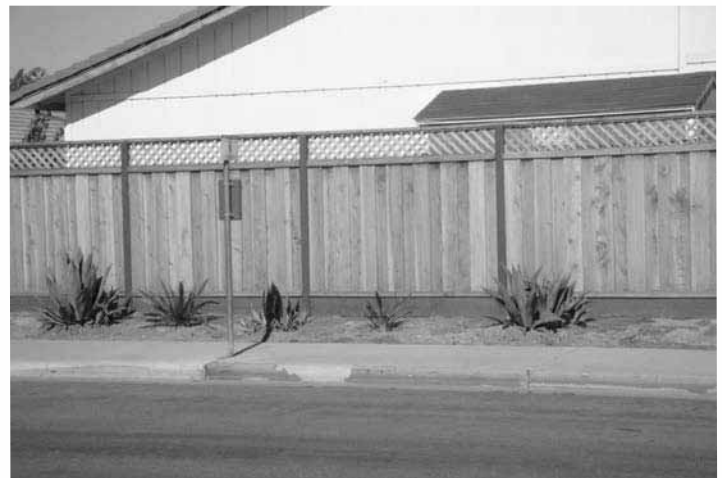
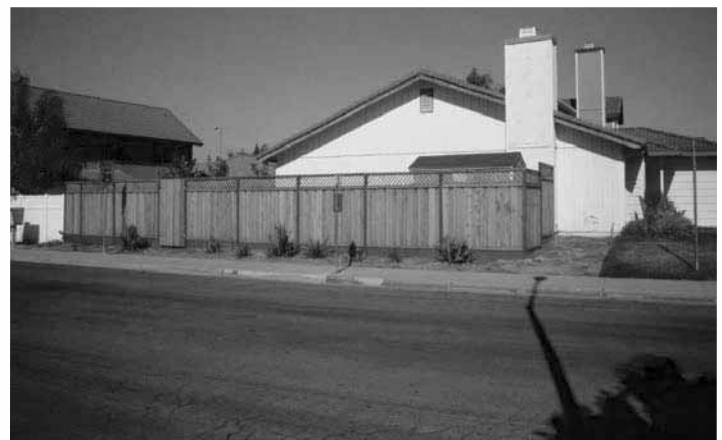
#40

- Bus stop currently serves the Green line
- Adequate signpost indicating bus stop
- Effective sidewalk: 4'6"
- Streetlight near bus stop
- Bus stop in residential area
- Red curb: 15'6"
- No parking in both direction
- Quality of road surface/concrete bus pad is good
- Bus will stop aligned with curb/parking lane
- Wheelchair ramps provided at all corners of adjacent side streets, driveways, and crosswalks
- Textured surfaces present at all the ramps at intersection
- Continuous sidewalk

View of the bus stop

- No shelter or bench
- No trash can or recycling bin
- Fixed signpost for route map and timetable appears vandalized
- Deteriorating paint on the 15'6" red curb
- No bicycle facility along the bus route
- No bicycle racks or lockers

View of the bus stop from across the street

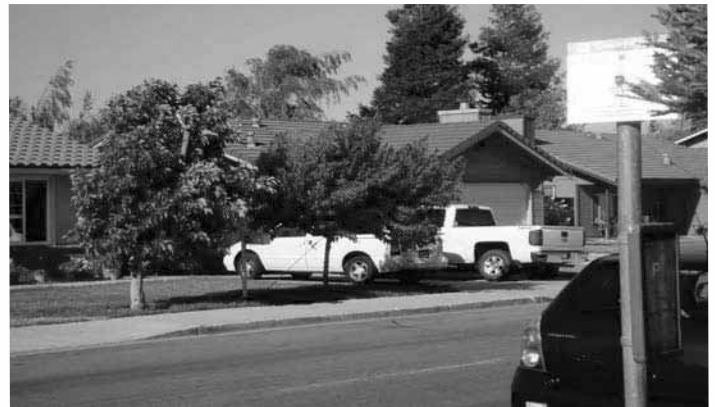
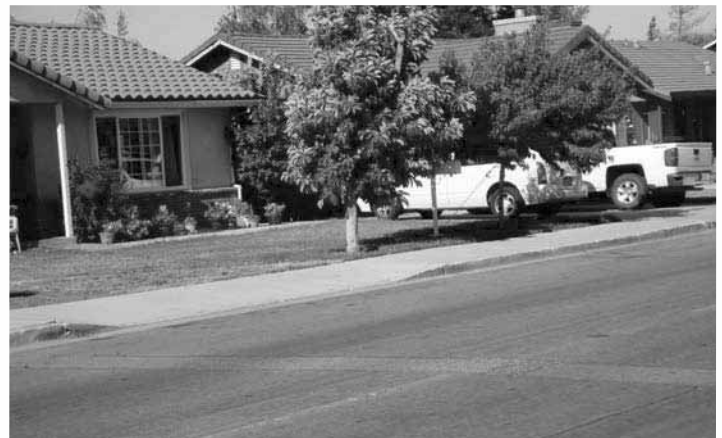
#41

- No signpost that indicates bus stop
- No system map, route map or timetable
- No shelter or bench
- No trash can or recycling bin
- Not clearly marked where the bus stop is located
- No red curb
- No bicycle facilities

View of the bus stop

View of the bus stop from across the street

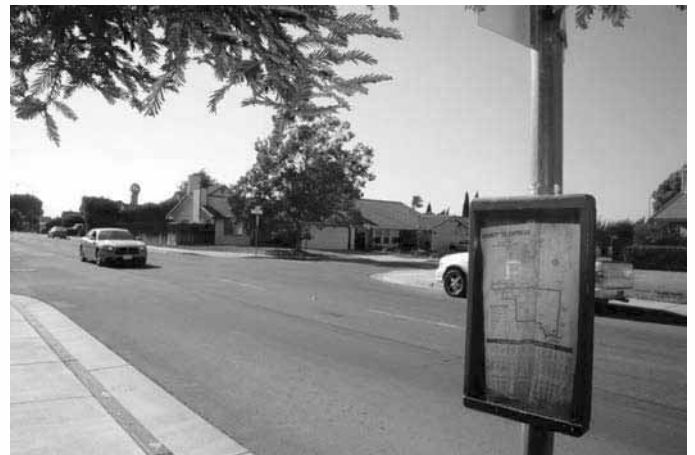
View of the bus stop

- No shelter or bench
- No trash can or recycling bin
- Fixed signpost for route map and timetable appears vandalized
- Deteriorating paint on the 50'0" red curb
- No bicycle facility along the bus route
- No bicycle racks or lockers

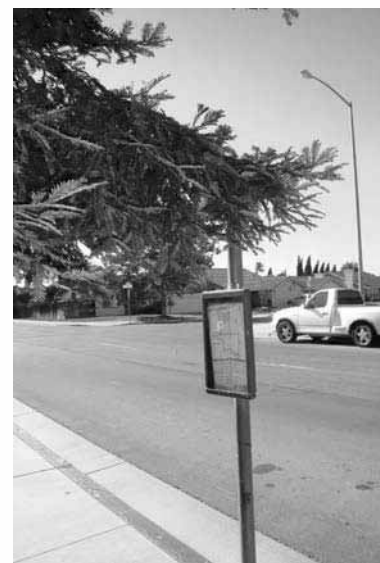
Tree branches covering the bus stop area

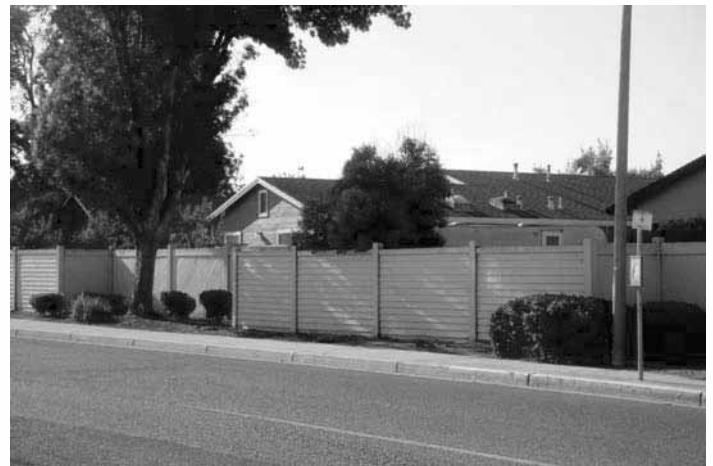
View of the Bus Stop from across the Street

- No shelter or bench
- No trash can or recycling bin
- Fixed signpost for route map and timetable appears vandalized
- Deteriorating paint on the 58'0" red curb
- No bicycle facility along the bus route
- No bicycle racks or lockers

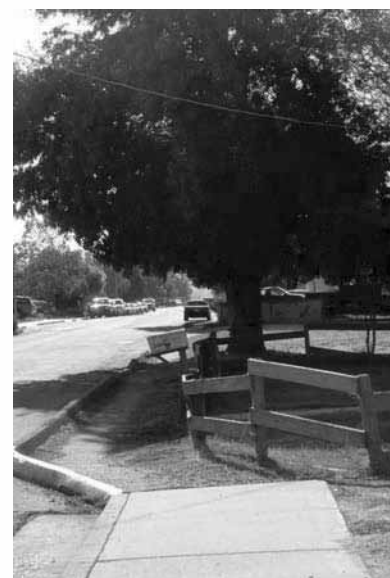
Sidewalk terminating 125' downstream from the bus stop

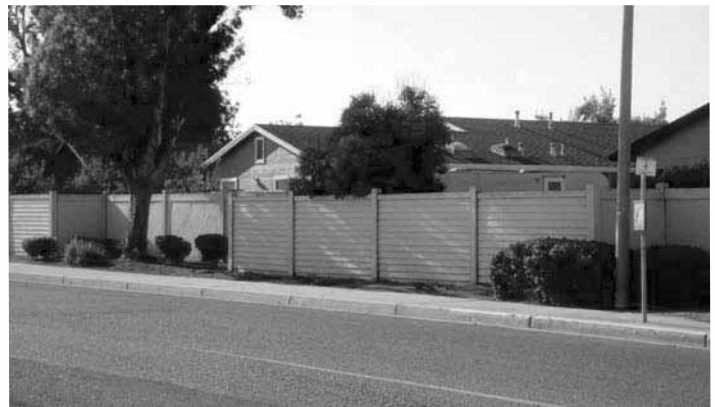
View of the Bus Stop

- No route map or timetable
- No shelter or bench
- No trash can or recycling bin
- Not clearly marked where the bus stop is located

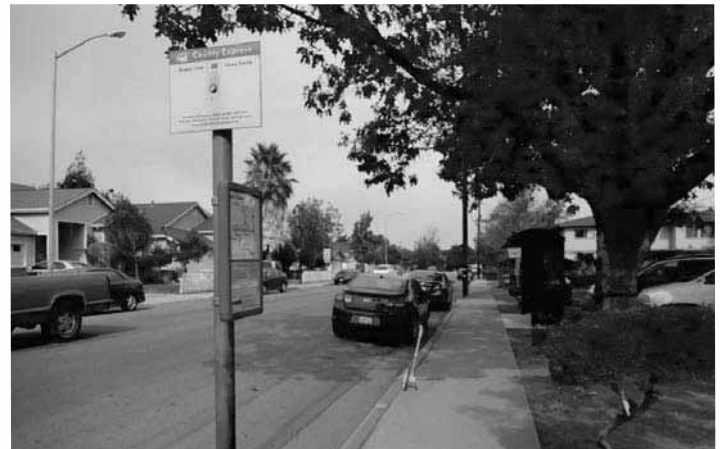
View of the bus stop

- No recycling bin
- No bicycle facility along the bus route
- No bicycle racks or lockers
- "No Parking" sign and enforcement needed

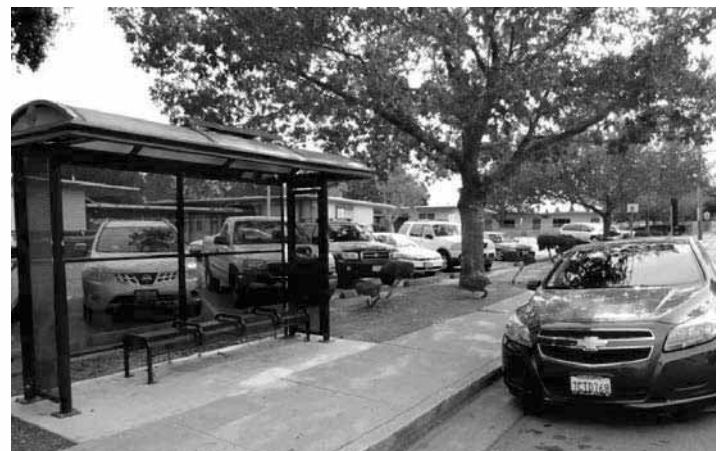
No red curb along bus shelter

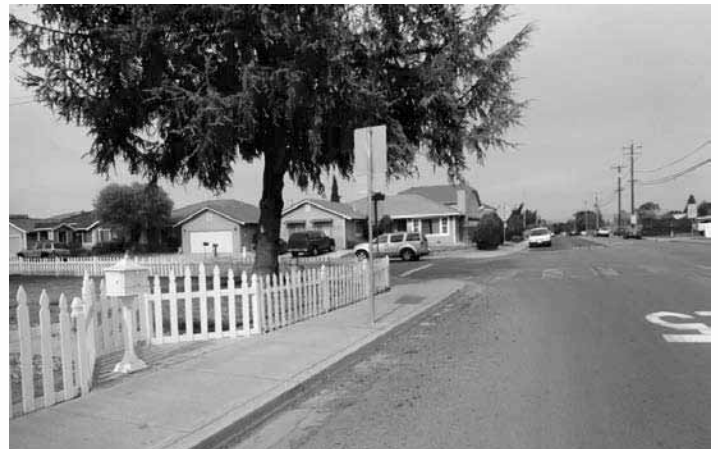
- No bus shelter or bench
- No bus stop signpost
- No system map, route map, or route timetable
- No trash can or recycling bin
- No bicycle facility along the bus route
- No bicycle racks or lockers
- No textured ramp at this intersection

Red curb at the bus stop without any bus stop signage

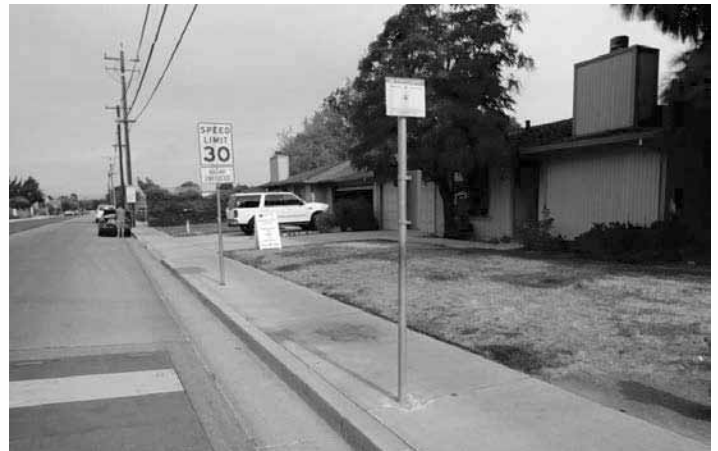
View of the bus stop

- No bus shelter or bench
- No trash can or recycling bin
- No bicycle facility along the bus route
- No bicycle racks or lockers
- No textured ramp at this intersection

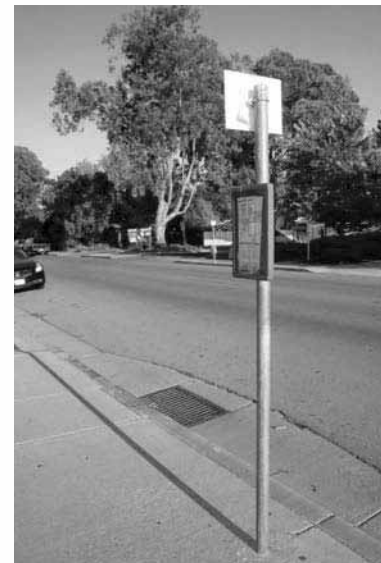
View of the bus stop

- No shelter or bench
- No trash can or recycling bin
- Fixed signpost for route map and timetable appears vandalized
- Deteriorating paint on the 44'0" red curb
- No bicycle facility along the bus route
- No bicycle racks or lockers
- No textured surfaces at wheelchair ramps at intersections

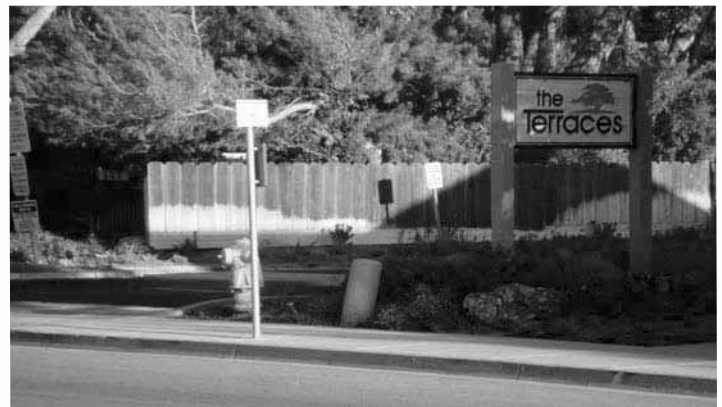
View of the bus stop from across the street

- No shelter or bench
- No trash can or recycling bin
- Fixed signpost for route map and timetable appears vandalized
- Deteriorating paint on the 33'6" red curb
- No bicycle facility along the bus route
- No bicycle racks or lockers
- No textured surfaces at wheelchair ramps at intersections

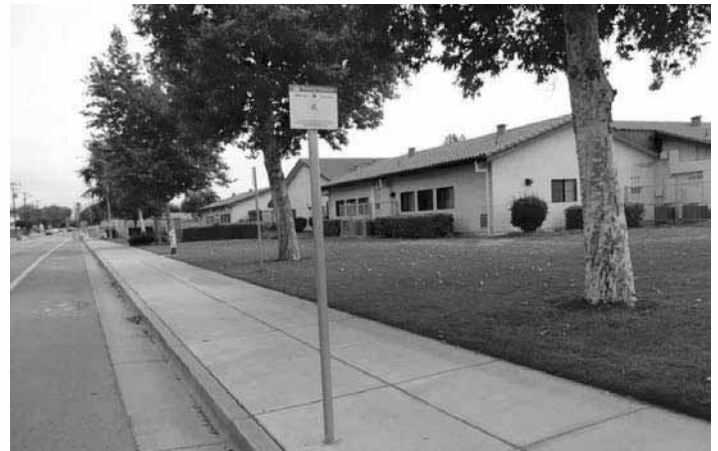
View of the bus stop

- No trash can or recycling bin
- No bus shelters or benches
- No bicycle facility along the bus route
- No bicycle lockers
- No system map, route map, or route timetable sign attached to the signpost

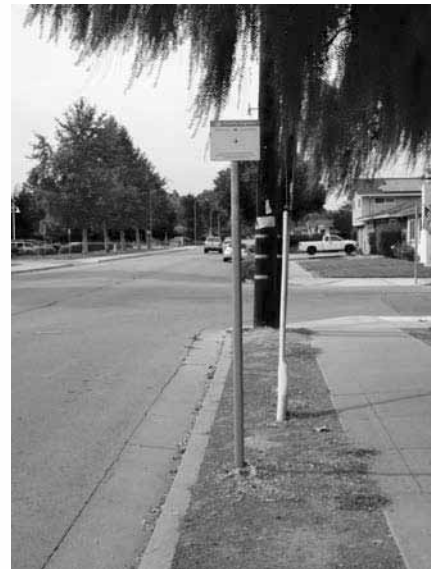
- No trash can or recycling bin
- No bus shelters or benches
- No bicycle facility along the bus route.
- No Red curb painted
- No bicycle lockers
- No system map, route map, or route timetable

View of the bus stop

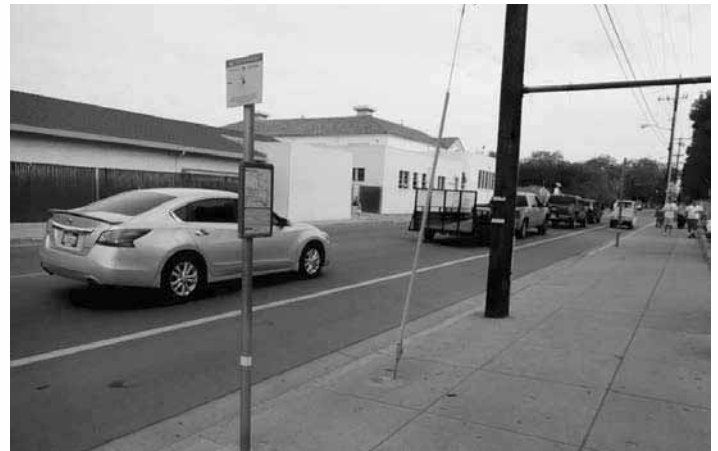
View of the bus stop

- No bus shelter or bench
- No trash can or recycling bin
- No bicycle racks or lockers
- Damaged system map, route map, or route timetable need replacement
- Red curb need repainting

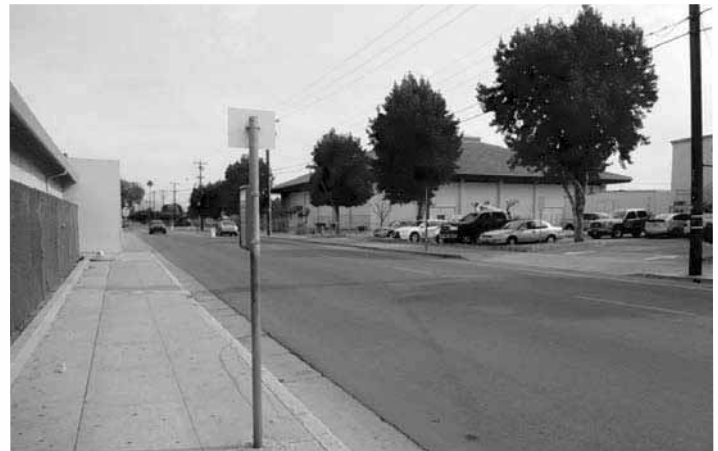
View of the bus stop

- No bus shelter or bench
- No trash can or recycling bin
- No bicycle facility along the bus route
- No bicycle lockers
- No ADA compliant textured surfaces at the wheelchair ramps

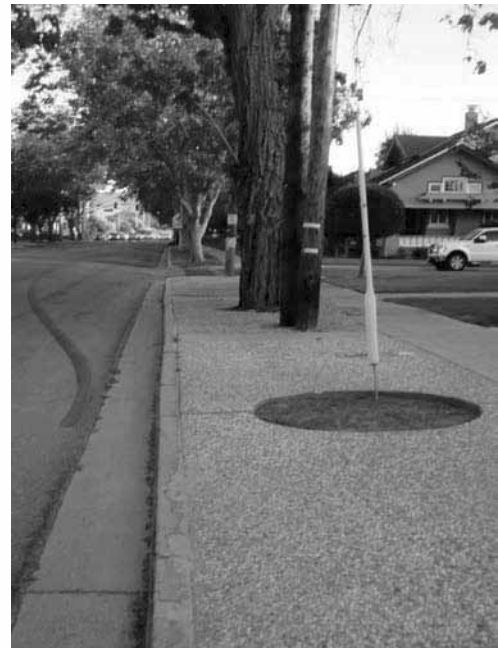
- No shelter or bench
- No trash can and recycling bin
- No bicycle facility along the bus route
- No bicycle racks or lockers
- No bus stop signage
- No sign post
- No system map, route map or route time table
- Bus stop not in an ideal location due to hanging wires and pavement cracks

View of the bus stop

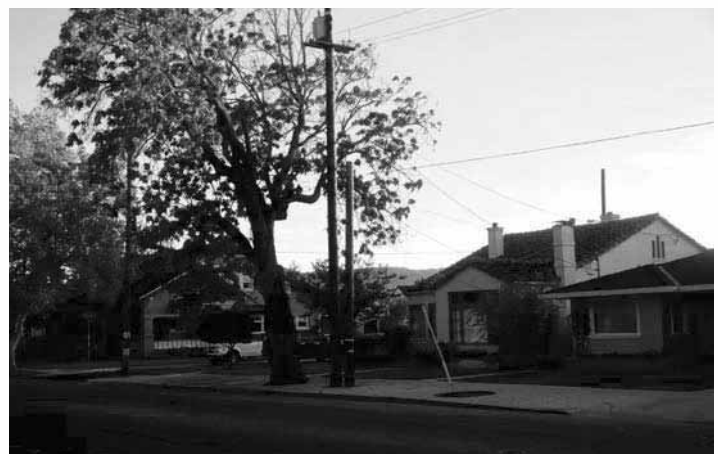
San Benito Street & E Park Street

View of the bus stop from across the street

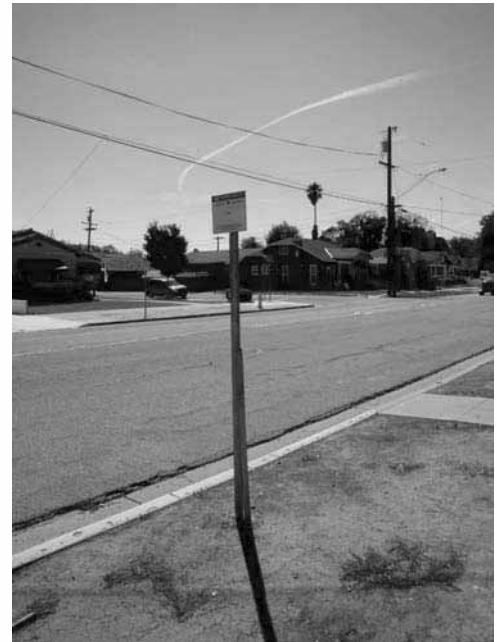
#56

- No shelter or bench
- No trash can or recycling bin
- No bicycle facility along the bus route
- No bicycle racks or lockers
- No route map and timetable on the signpost
- Textured surfaces are missing for some ramps at the upstream and downstream intersections
- Red curb needs repainting

View of the bus stop

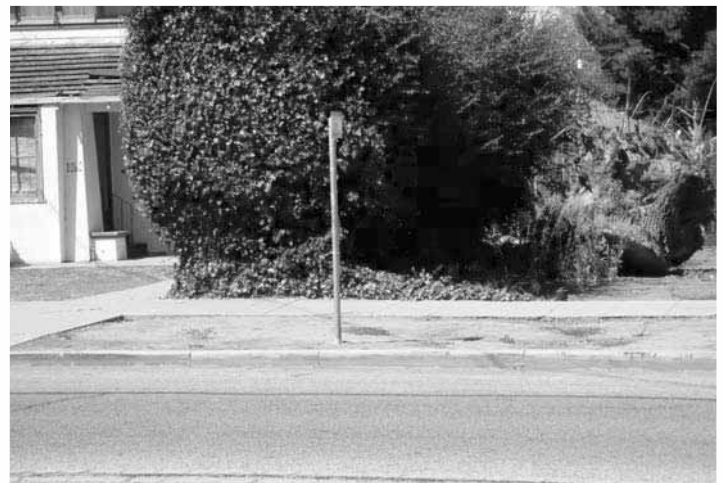
View of the bus stop from across the street

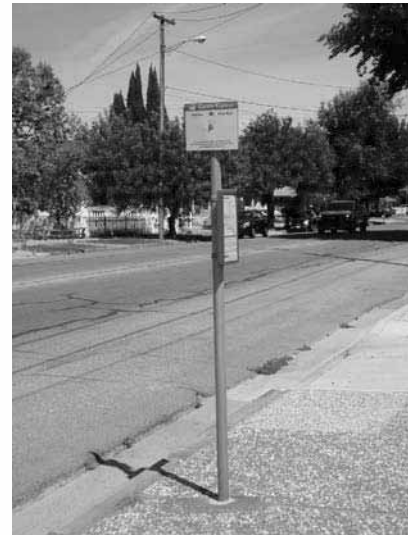
● #57

- Bus stop currently serves Red line in the northbound direction
- Adequate signpost indicating bus stop with route information
- System map, route map and route time table for buses in good condition
- Adequate lighting in the street
- Red curb measuring approximately 46'6"
- Sidewalk along bus stop measures 5'0"
- Bus stop in residential area
- Bus will stop aligned with curb/parking lane
- Wheelchair ramps at upstream and downstream intersections
- Underground water meters within 100'0" of the bus stop

View of the bus stop

- No bench or shelter
- No trash can or recycling bin
- No bicycle facility along the bus route
- No bicycle racks or lockers
- No streetlight near bus stop
- Sidewalk does not exist on both sides
- No wheelchair ramps provided at all corners of adjacent side streets, driveways, and crosswalks
- Textured surfaces are missing for some ramps at the upstream and downstream intersections
- Red curb needs repainting
