**AGENDA
REGULAR MEETING
LOCAL TRANSPORTATION AUTHORITY**

5. **RECEIVE** Presentation on the San Benito County Local Transportation Authority's Bus Stop Improvement Plan (BSIP) and **ACCEPT** the Final Report – Gilbert

The San Benito County Local Transportation Authority (LTA) Bus Stop Improvement Plan is a planning document that summarizes findings and details results and recommendations of the County Express Bus Stop Improvement Project. The objectives of the project was aimed to evaluate existing conditions of the bus stops operated by the LTA, incorporate input from the public with the findings, provide recommendations for improvements, costs estimates, and conceptual design, and prioritize bus stops for improvements. The key tasks of the project include the following:

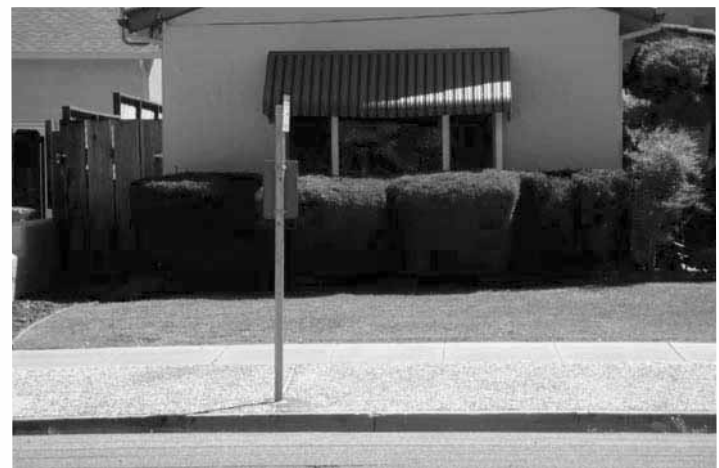
● #57

- No bench or shelter
- No trash can or recycling bin
- No bicycle facility along the bus route
- No bicycle racks or lockers
- No streetlight near bus stop
- Sidewalk does not exist on both sides
- No wheelchair ramps provided at all corners of adjacent side streets, driveways, and crosswalks
- Textured surfaces are missing for some ramps at the upstream and downstream intersections
- Red curb needs repainting

View of the bus stop from across the street

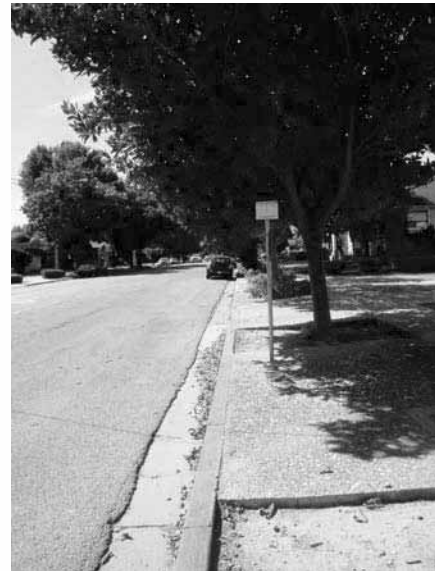
#58

- Bus stop serving southbound Red line
- Signpost indicating bus stop is in good condition
- System map, route map and route time table for buses
- Adequate lighting in the street
- Red curb measuring approximately 37'0" needs repainting, excludes the 10'0" driveway in between
- Sidewalk along bus stop measures 5'0"
- Bus stop in residential & commercial area
- Bus will stop aligned with curb/parking lane
- Quality of road surface at the bus stop is good
- Sidewalk and pavement near the bus stop needs resurfacing and/or reconstruction
- Huge tree boxes on either side of the bus stop

View of the bus stop

- No trash can or recycling bin
- No bicycle facility along the bus route
- No bicycle racks or lockers
- No streetlight near bus stop
- No Wheelchair ramps provided at all corners of adjacent side streets, driveways, and crosswalks
- Sidewalk pavements are cracked and need repairs

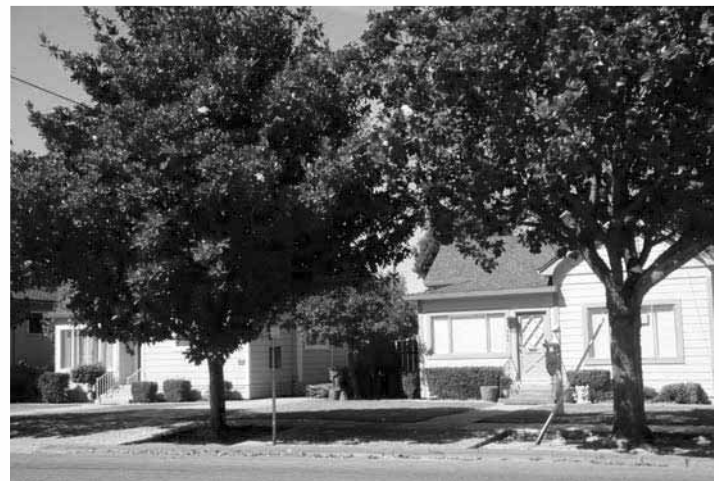
View of the bus stop from across the street

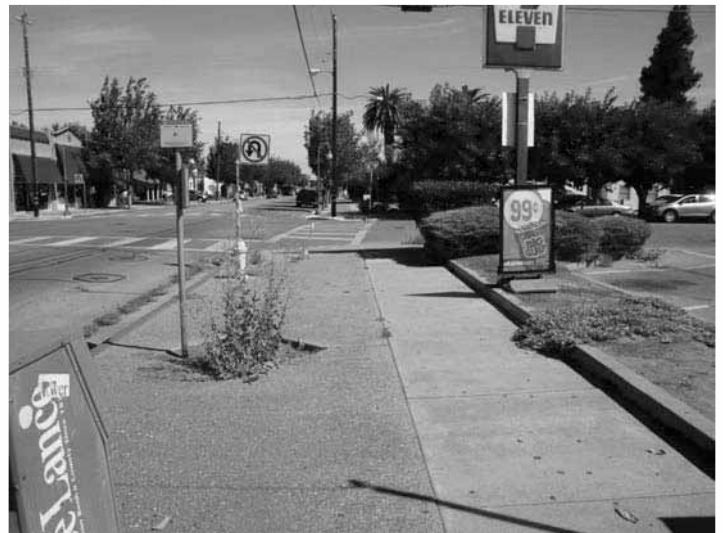
#59

- Bus stop serving the Red line in the northbound direction
- Adequate signpost indicating bus stop
- Fixed signpost with attached system map, route map and route timetable in good condition
- Adequate lighting in the street with decorative lamp posts at the intersection
- Red curb measuring approximately 53'6" in good condition
- Sidewalk along bus stop measures 8'6"
- Bus stop in residential and commercial area
- Bus will stop aligned with curb/parking lane
- Quality road surface/concrete bus pad
- Wheel chair ramps provided at intersection
- Newspaper stand and payphone nearby
- Underground water meters within 100'0" of the bus stop
- Downtown commercial area begins downstream of this bus stop

View of the bus stop

- No recycling bin in the vicinity
- No bicycle facility along the bus route
- No bicycle racks or lockers
- No streetlight near bus stop
- No system map, route map and timetable in vicinity

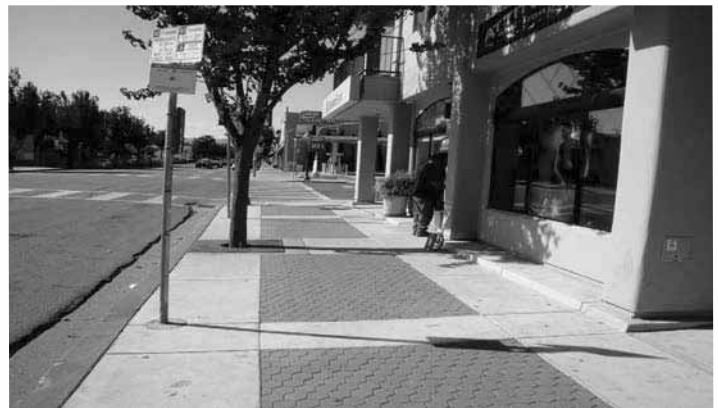
#60

- Bus stop currently serving southbound Red line
- Adequate signpost indicating bus stop
- System map, route map and route time table for buses in good condition
- Adequate street lighting and decorative lamp posts in the downtown neighborhood
- Red curb at bus stop measuring approximately 45'6" in good condition
- Sidewalk along bus stop measures 8'0" and is made of decorative pavers and concrete
- Parking signs in the area indicating a 3-hour limit
- Bus stop in downtown office and commercial area
- Bus will stop aligned with curb/parking lane
- Trash can on the street within 60'0"
- Quality road surface near bus pad is good
- Wheel chair ramps provided at nearby intersections
- Surrounding land uses are downtown commercial and office spaces
- Bicycle rack spaces for two bicycles nearby on the sidewalk
- Underground electrical boxes within 100'0" of the bus stop

View of the bus stop

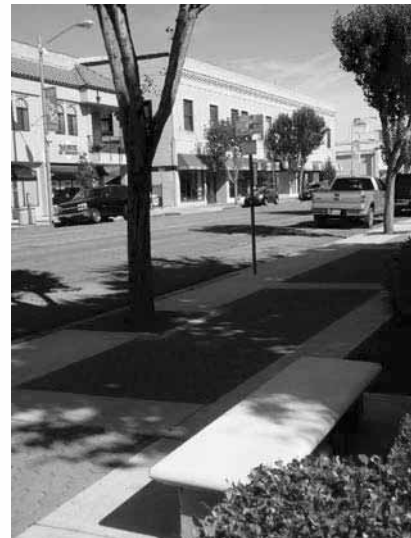
#61

- Fixed signpost with route information in good condition
- System map, route map and route timetable for buses fixed on the signpost is in good condition
- Bench nearby measuring 5'6"X1'6"
- Lots of shaded area due to trees in the downtown neighborhood
- Adequate lighting in the street, including decorative lights in the downtown area
- Red curb at stop measuring approximately 43'0"
- 'No Parking Signs' near bus stop
- Sidewalk along bus stop measures 8'6" is made of decorative pavers and concrete
- Bus will stop aligned with curb/parking lane
- Quality road surface near bus pad is good
- Wheel chair ramps provided at nearby intersections
- Surrounding land uses are downtown commercial and office spaces

Bus stop with decorative pavers and bench

- No shelter
- No trash can or recycling bin
- No bicycle facility along the bus route
- No bicycle racks or lockers
- Wheelchair ramps at nearby intersections need ADA compliant textured surfaces

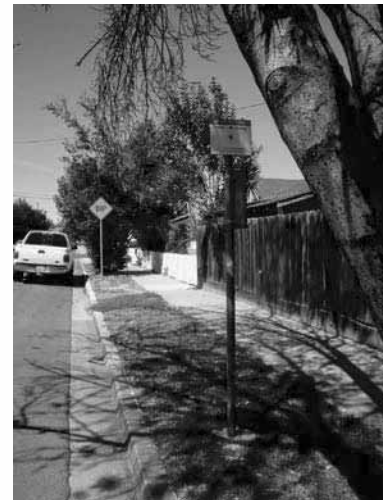
#62

- Bus stop currently serving northbound Red line
- Signpost indicating bus stop in good condition
- Adequate lighting in the street
- Red curb measuring approximately 47'0" at bus stop
- Sidewalk along bus stop measures 5'0"
- Bus stop in residential area and school nearby
- Quality of road surface bus pad is good
- Bus stop in residential neighborhood close to school and downtown business district
- Tree branches overhanging on the sidewalk near the bus stop creating a tripping hazard
- Sidewalk pavement doesn't extend until the curb
- Wheelchair ramps at nearby intersections have ADA compliant textured surfaces

View of the bus stop

- No shelter or bench
- No trash can or recycling bin
- No bicycle facility along the bus route
- No bicycle racks or lockers
- Red curb needs repainting
- Tree branches need to be trimmed
- Bus stop not ADA friendly as the sidewalk pavement doesn't extend to the curb

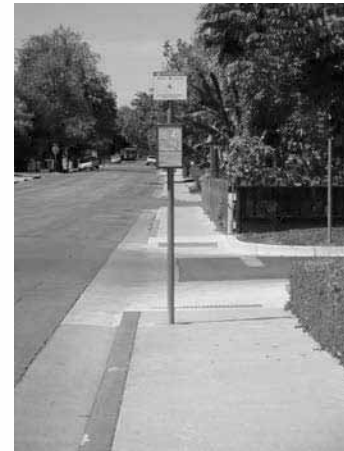
● #63

- Bus stop currently serving Red line in the northbound direction
- Adequate signpost indicating bus stop
- System map, route map and route timetable in good condition
- Adequate lighting in the street
- Deteriorating red curb measuring approximately 52'0" long at bus stop
- Sidewalk along bus stop measures 5'0"
- School and senior housing nearby
- Lots of red curb and 'No Parking' signs nearby due to school
- Bus stop in residential area and school nearby
- Quality of road surface near the bus stop is good

View of the bus stop

- No bench or shelter
- No trash can or recycling bin
- No bicycle facility along the bus route
- No bicycle racks or lockers

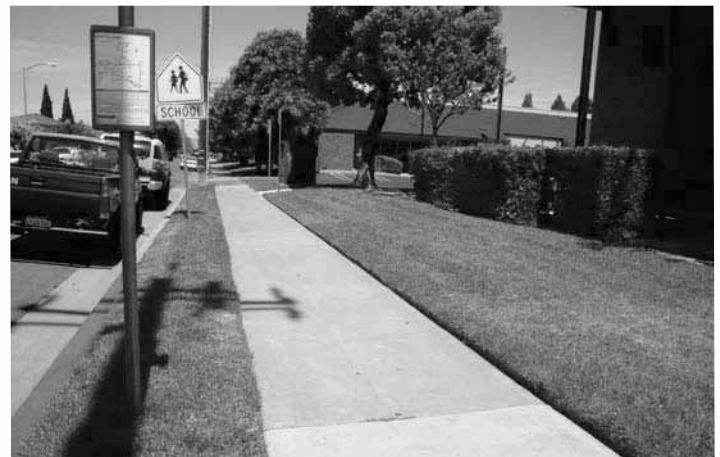
#64

- Bus stop currently serving the northbound Red line
- Adequate signpost indicating bus stop but is missing the sign indicating the bus stop
- System map, route map and route timetable fixed on the signpost is in good condition
- Adequate lighting in the street
- Red curb measuring approximately 60'0" long at bus stop in very good condition
- Sidewalk along bus stop measures 5'0"
- Bus stop in commercial area
- Quality of road surface near the bus stop is good
- Several school zone signs and 'No Parking' signs nearby
- Underground utility boxes for PG&E within 100'0" of bus stop
- Commercial, office and retail land uses in the vicinity

View of the bus stop

- No bench or shelter
- No trash can or recycling bin
- No bicycle facility along the bus route
- No bicycle racks or lockers
- Sidewalk across the street at Tres Pinos Road/Nash Road needs to be repaved

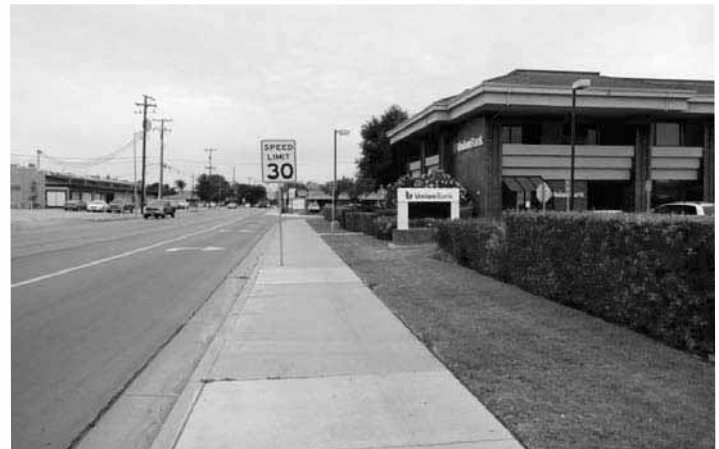
● ● #65

- Bus stop currently serves Red and Green lines in the westbound direction on Tres Pinos Road
- No signpost indicating bus stop
- Street lighting near the bus stop
- Quality of road surface is in good condition
- Sidewalk along bus stop measures 7'4"
- "No Parking" sign without red curb near the bus stop
- A right turn lane shared the location with the potential bus stop
- Commercial land use around the bus stop
- Wheelchair ramps are provided
- Textured ramp at this intersection
- Lawn may be used for shelter

Bus stop location near turn lane without red curb

- No bus shelter or bench
- No signpost, system map, route map, or timetable
- No trash can or recycling bin
- No bicycle facility along the bus route
- No bicycle racks or lockers

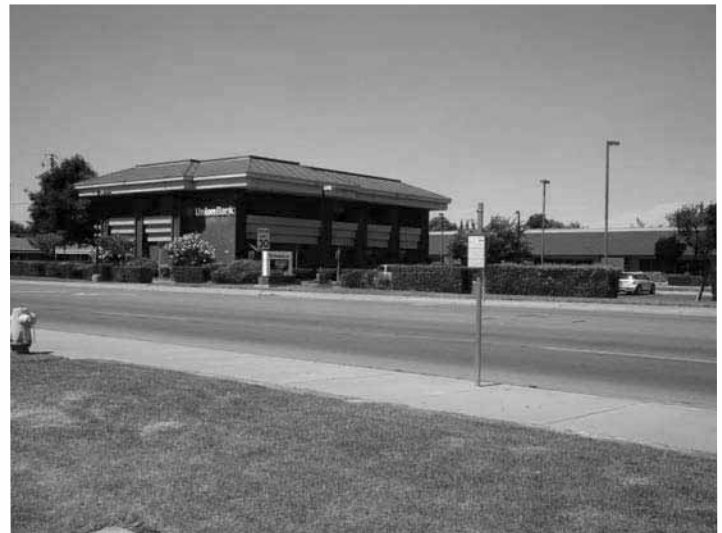
● ● #66

- Bus stop currently serving the Red and Blue lines
- Fixed signpost indicating bus stop in good condition but is missing the route information sign on the top
- System map, route map and route timetable fixed on the signpost is in good condition
- Adequate lighting in the street
- Red curb at approximately 56'0" long at bus stop
- Sidewalk along bus stop measures 7'0"
- Road widens from single lane to double lanes just before the bus stop
- Bus stop in commercial area
- Quality of road surface is good.
- Underground PG&E and water meters within 100'0" of the bus stop
- Wheelchair ramps provided at nearby intersections, including ADA compliant textured surfaces
- Commercial and retail land uses nearby

View of the bus stop

- No bench or shelter
- No trash can or recycling bin
- No bicycle facility along the bus route
- No bicycle racks or lockers
- Sidewalk leading to the bus stop needs to be reconstructed
- Red curb needs repainting

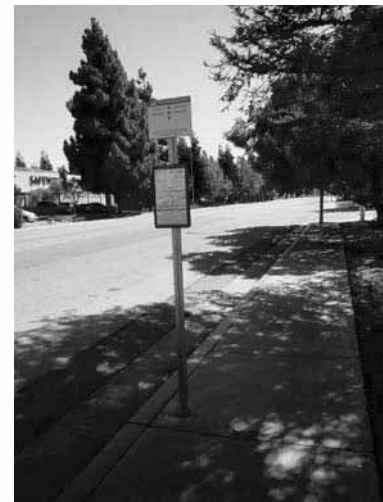
● ● #67

- Bus stop currently serves the southbound Red line, and Blue lines
- Adequate signpost with route information in good condition
- System map, route map and route time table in good condition
- Adequate lighting in the street
- Sidewalk along bus stop measures 4'10"
- Bus stop aligned with curb/parking lane in a commercial/retail area
- Red curb for the entire block including the bus stop
- Quality of road surface is good
- Class II bicycle lane begins after this stop
- Utility boxes in the vicinity
- Wheelchair ramps provided at nearby intersections and driveways
- ADA compliant textured surfaces for wheelchair ramps at upstream and downstream intersections

View of the bus stop

- No shelter or bench
- No trash can or recycling bin
- No bicycle racks or lockers
- Tree trimming needed for sidewalk clearance

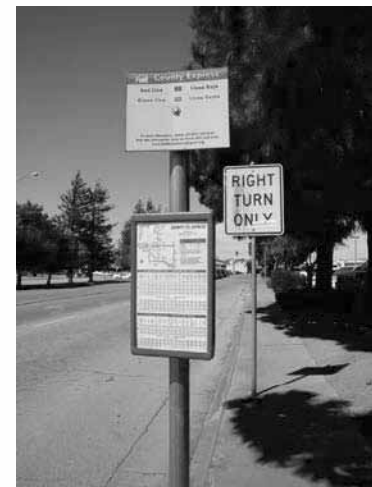
#68

- Bus stop currently serves the northbound Red line, and Green lines
- Adequate signpost indicating bus stop
- System map, route map and route time table in good condition
- Adequate lighting in the street
- Red curb at bus stop with "No Parking Anytime" sign
- Sidewalk along bus stop measures 4'8"
- Bus stop aligned with curb/parking lane in commercial area
- Quality of road surface is good
- Utility boxes in the vicinity
- Wheelchair ramps provided at nearby intersections and driveways
- ADA compliant textured surfaces for wheelchair ramps at upstream and downstream intersections
- Class II bike lane along the southern section of the road but ends just before the bus stop

View of the bus stop

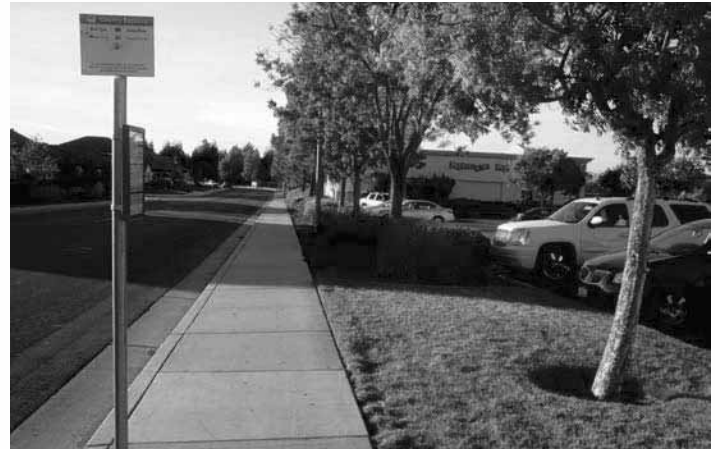
- Bus stop currently serves the Red and Blue lines
- Adequate signpost indicating bus stop
- System map, route map and route time table in the vicinity
- Adequate lighting in the street
- Sidewalk along bus stop measures 5'0" (in good condition)
- Bus stop aligned with curb/parking lane in a commercial and residential area
- Quality of road surface is good
- Utility boxes in the vicinity
- Wheelchair ramp provided

View of the bus stop

- No shelter or bench (need space for shelter)
- No trash can or recycling bin
- No bicycle facility along the bus route
- No Bicycle racks or lockers
- No red curb along the stop

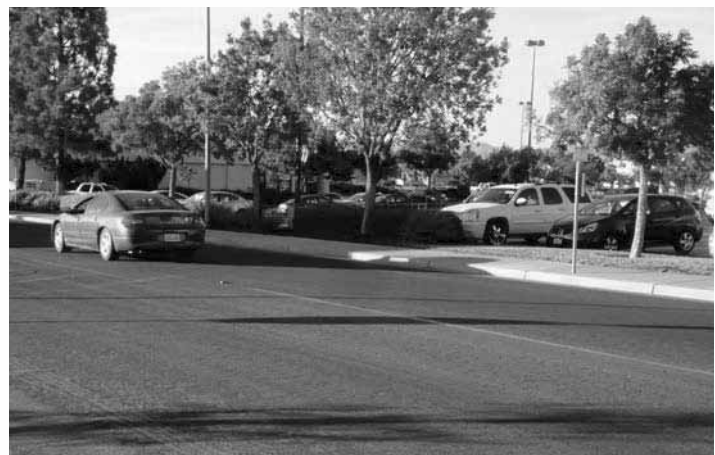
View of the bus stop from across the street

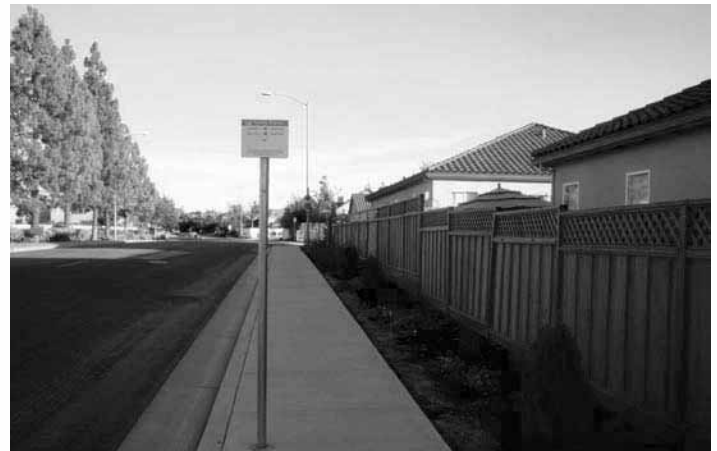
- Bus stop currently serves the Red and Green lines
- Adequate signpost indicating bus stop
- No system map, route map or route time table in the vicinity
- Adequate lighting in the street
- Sidewalk along bus stop measures 5'0" in good condition
- No existing red curb
- Bus stop aligned with curb/parking lane in a commercial and residential area
- Quality of road surface is good
- Utility boxes in the vicinity
- Wheelchair ramps provided at nearby intersections and driveways
- Observed many wheelchair customers waiting for bus

View of the bus stop

- No shelter or bench (the fence against the sidewalk limits the room for shelter)
- No trash can or recycling bin
- No bicycle facility along the bus route
- No Bicycle racks or lockers
- No red curb along the stop
- Wheelchair access improvements needed

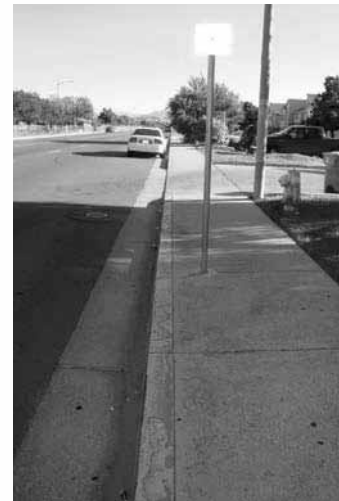
- Bus stop currently serves the Green line
- Adequate signpost indicating bus stop
- Effective sidewalk: 3'8"
- Streetlight near bus stop
- Bus stop in residential area
- Red curb: 50'0"
- Quality of road surface/concrete bus pad is good
- Bus will stop aligned with curb/parking lane
- Continuous sidewalk
- Utility boxes near the bus stop area
- Wheelchair ramps provided at all corners of adjacent side streets, driveways, and crosswalks
- Textured surfaces at wheelchair ramps at intersections

View of the bus Stop

- System map, route map, and route time table are missing
- No shelter or bench
- No trash can or recycling bin
- Deteriorating paint on the 50'0" red curb
- No bicycle facility along the bus route
- No bicycle racks or lockers

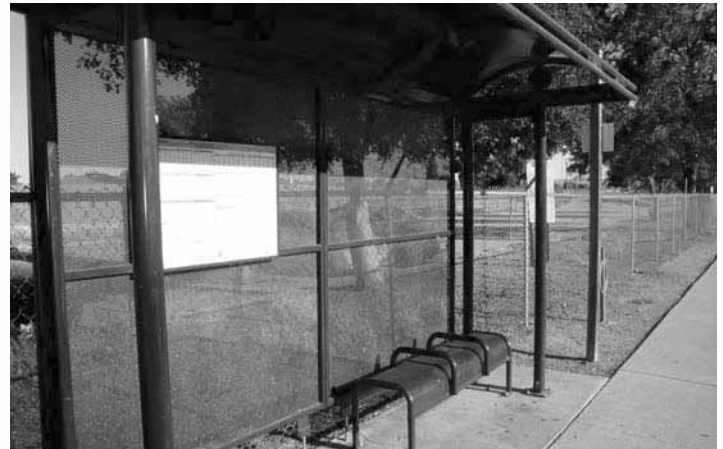
- Bus currently serves the Blue line and the Inter-County line
- Bus stop next to a Park-n-Ride lot serving Inter County bus line
- One shelter measuring 11'09" x 2' 10" recessed from the sidewalk
- Space for a wheelchair inside the shelter
- One bench inside shelter measuring 5'2" x 2'8"
- Red curb: 51'8"
- Effective sidewalk: 5'2"
- Adequate wooden signpost indicating bus stop
- Fixed signpost for route map and timetable, includes inter-county map
- Bus stop in recreational and residential area
- Bicycle rack: vertical "Q" poles for two bicycles
- Streetlight near bus stop and lighting in the shelter
- Bus stop aligned with curb/parking lane
- Quality of road surface is good
- Wheelchair ramps provided at all corners of adjacent side streets, driveways, and crosswalks
- Textured surfaces present on wheelchair ramps at upstream & downstream intersections
- Continuous sidewalk

View of the bus stop

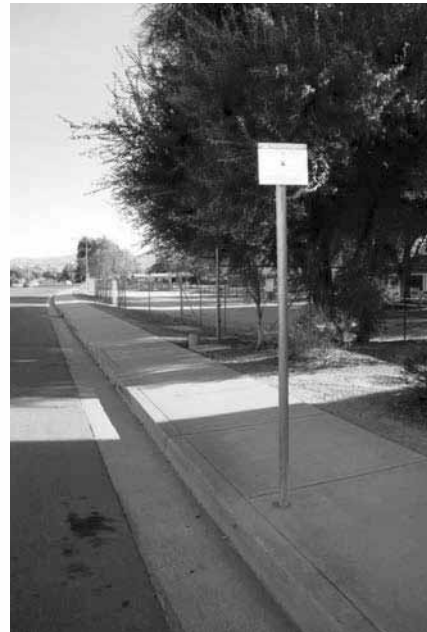
- Bus stop currently serves the Green line
- Adequate signpost indicating route information
- Effective sidewalk: 5'6"
- Missing route map and timetable
- Streetlight near bus stop
- Bus stop in residential area
- Quality of road surface/concrete bus pad is good
- Bus will stop aligned with curb/parking lane
- Continuous sidewalk
- Bus stop is located mid-block on a lengthy block

View of the bus stop

- No shelter or bench
- No trash can or recycling bin
- No system map, route map and timetable
- No red curb at the bus stop
- No bicycle facility along the bus route
- No bicycle racks or lockers
- Lack of a mid-block crosswalk

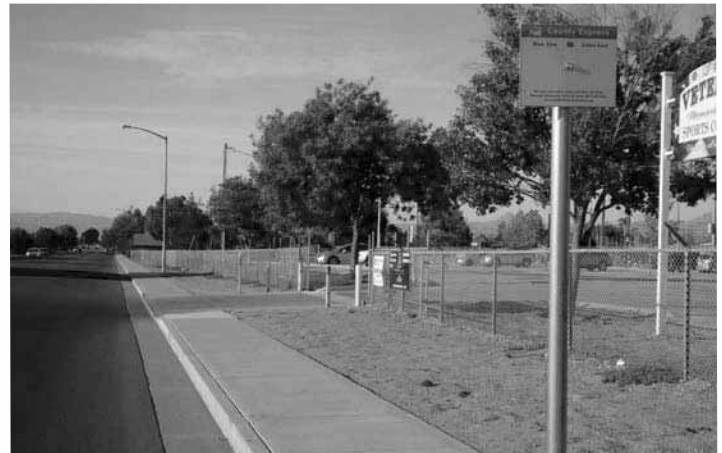
- Bus stop currently serves the Blue line
- Adequate signpost indicating bus stop
- Effective sidewalk: 5'6" (in good condition)
- Streetlight near bus stop
- Bus stop in residential area
- Quality of road surface/concrete bus pad is good
- Bus will stop aligned with curb/parking lane
- Continuous sidewalk
- Sports complex and parking lot located at the bus stop
- Bus stop is located mid-block on a lengthy block

View of the bus stop

- No shelter or bench
- No trash can or recycling bin
- No system map, route map and route timetable
- No red curb at the bus stop
- No bicycle facility along the bus route
- No bicycle racks or lockers
- Lack of a mid-block crosswalk

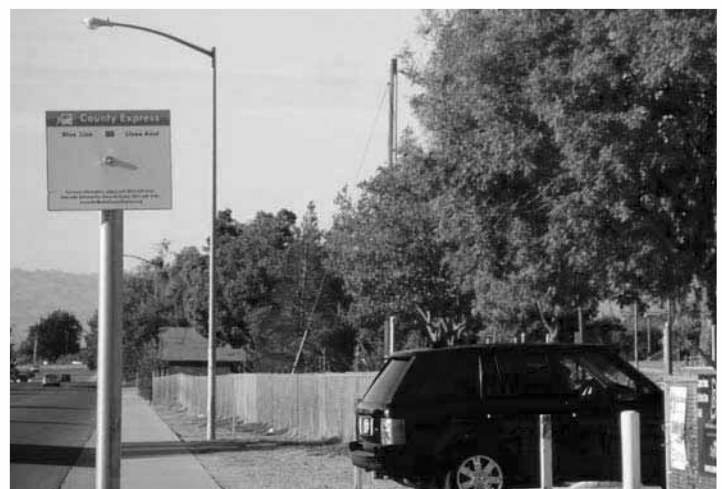
Bus stop sign showing route information next to Veterans Park parking lot driveway

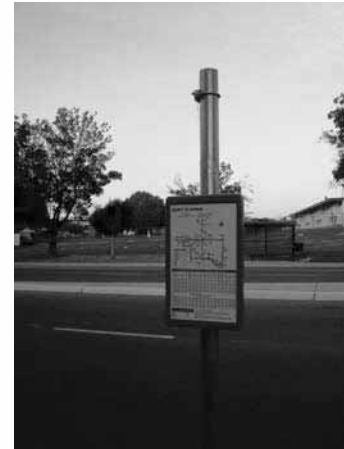
- Bus stop currently serves the Green line
- Adequate signpost along with system map, route map, and route timetable
- Street lighting near the bus stop
- Quality of road surface is in good condition
- Sidewalk along bus stop measures 5'0"
- Red curb along the entire block
- "No Parking" sign on the block
- Office and school land uses around the bus stop
- Bus stop location aligned within travel lane
- Wheelchair ramps are provided
- Textured ramp at this intersection
- Street median in on Memorial Drive

View of the bus stop

- Route sign is missing
- No bus shelter or bench
- No trash can or recycling bin
- Tree branches
- No bicycle facility along the bus route
- No bicycle racks or lockers
- This stop is not shown on Google Maps
- No mid-block crosswalk of which creates difficulties for pedestrian to cross

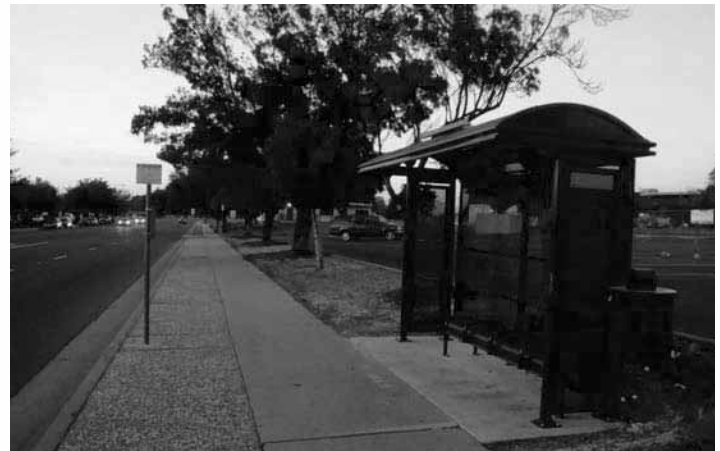
- Bus stop currently serves the Blue line in the northbound direction
- Adequate signpost along with system map, route map, and route timetable
- One adequate shelter: 11'6" x 2'6" (mostly clean with minor graffiti)
- The shelter is recessed from sidewalk
- One bench: 8' x 1'6"
- Less street lighting but solar lighting found inside shelter
- Quality of road surface is in good condition
- Sidewalk along bus stop measures 9'3"
- Red curb extends the entire block (in good condition)
- School and offices around the bus stop
- Bus stop location within travel lane
- Wheelchair ramps are provided
- Textured ramp at this intersection
- Street median on Memorial Drive
- May be room for bicycle racks for the school

View of the bus stop

- No bus shelter or bench
- No trash can or recycling bin
- No bicycle facility along the bus route
- No bicycle racks or lockers

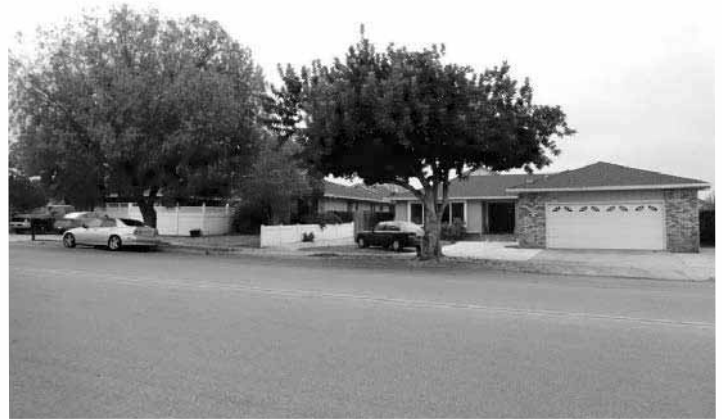
- Bus stop currently serves the Green line
- No signage to indicate the bus stop, but survey done per bus driver's comments
- Curbside parking is available on both sides
- Effective sidewalk: 4'0"
- Adequate street lighting
- Bus stop in residential area
- Quality of road surface is good
- Wheelchair ramps provided at all corners of adjacent side streets, driveways, and crosswalks
- Wheelchair ramps have ADA compliant textured ramps

View of the bus stop from across the street

- No signpost found in this location
- No system map, route map, or route timetable
- No shelter or bench
- No trash can or recycling bin
- No red curb at Bus stop
- No bicycle facility along the bus route
- No bicycle racks or lockers

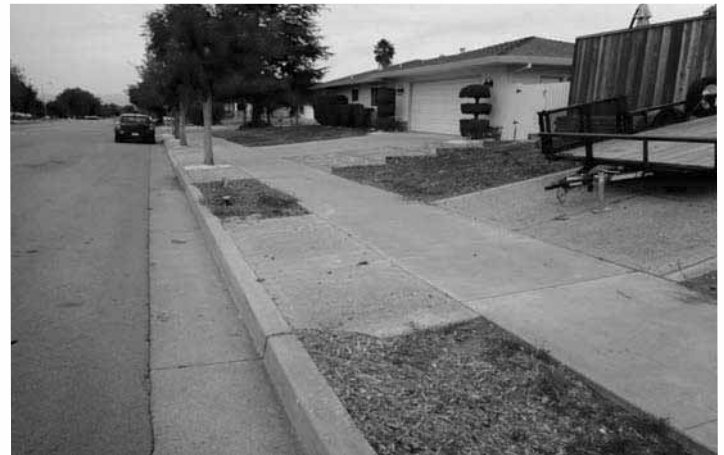
- Bus stop currently serves the Blue line
- No signage to indicate the bus stop, but survey done per bus driver's comments
- Curbside parking is available on both sides
- Effective sidewalk: 4'0"
- Streetlight near bus stop
- Bus stop in residential area
- Quality of road surface is good
- Wheelchair ramps provided at all corners of adjacent side streets, driveways, and crosswalks
- Wheelchair ramps have ADA compliant textured ramps

View of the bus stop

- No signpost found in this location
- No signage to indicated the bus stop
- No system map, route map, or route timetable
- No shelter or bench
- No trash can or recycling bin
- No red curb at Bus stop
- No bicycle facility along the bus route
- No bicycle racks or lockers

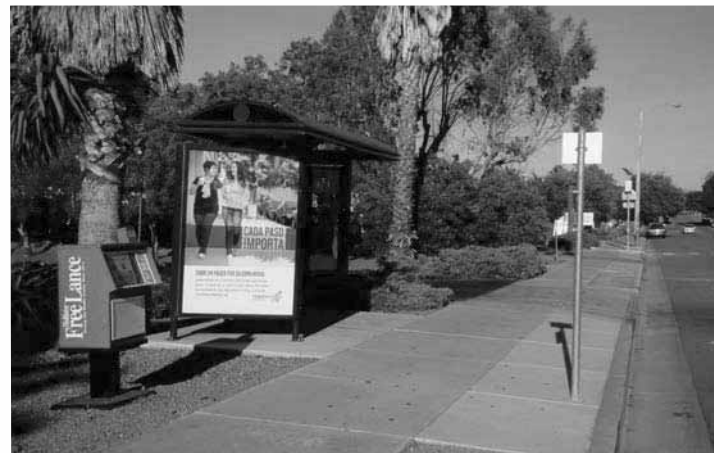
- Bus stop currently serves the starting point for the Red and Green lines
- One shelter: 12'6" x 3'6"
- Not enough space for a wheelchair inside the shelter
- One bench: 5'0" x 1'8"
- Adequate signpost in good condition with system map, route map, and route timetable
- Adequate lighting in the street
- Sidewalk along bus stop measures 8'6"
- Red curb along the bus stop measures 52'6" (additional 51'0" after the driveway)
- Quality of road surface is good.
- Wheelchair ramp provided at nearby intersections and driveways
- Mid-block crosswalk 100'0" from bus stop
- Bus stop next to a nursery facility and a hospital across the street
- Newspaper stand next to the shelter
- Bus stop location aligned with curb lane
- Trash lying around in the shelter and back side of the bus stop

View of the bus stop

- No trash can or recycling bin
- No bicycle facility along the bus route
- No bicycle racks or lockers
- Shelter may not be wheelchair-friendly

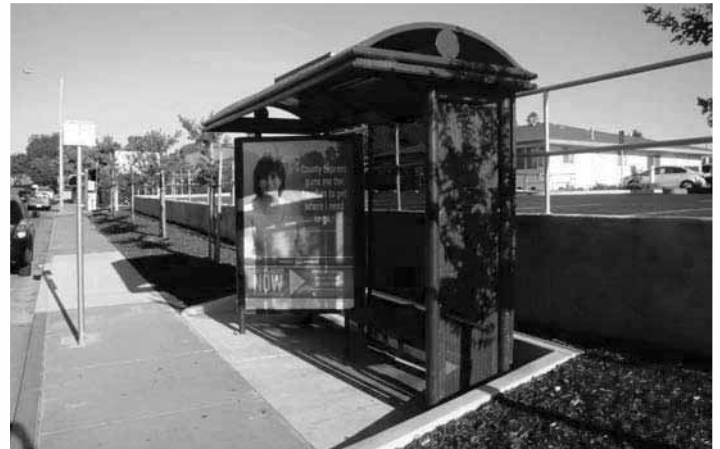
- Bus stop currently serves the Blue line eastbound at the Hazel Hawkins Memorial Hospital
- One (1) shelter measures 12'3" x 4'
- One (1) bench: 4'10" x 18"
- Adequate sign post in good condition
- Adequate lighting in the street
- Sidewalk along bus stop measures 4'10"
- Quality of road surface/concrete bus pad is good
- Wheel chair ramp provided
- Shelter is located right next to the hospital driveway
- Red curb at stop
- Trash lying inside and behind the bus stop
- Bus stop location aligned with curb lane

View of the bus stop

- No trash can or recycling bin
- No bicycle facility along the bus route
- No bicycle racks or lockers
- Angled shelter may not accommodate wheelchairs

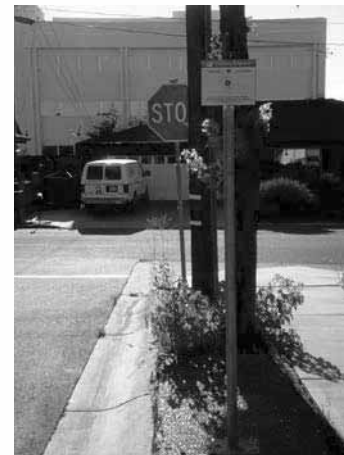
- Bus stop currently serves the Red line
- Adequate signpost indicating bus stop
- Bus stop in residential area, hospital in near vicinity
- Quality of road surface/concrete bus pad is good
- Bus will stop aligned with curb/parking lane
- Signpost is located between two (2) trees with low visibility

View of the bus stop

- System map, route map, and route timetable are missing
- No shelter or bench
- No trash can or recycling bin
- No red curb near bus stop
- No bicycle facility along the bus route
- No bicycle racks or lockers
- No streetlight near bus stop
- Sidewalk does not exist on both sides
- No wheelchair ramps provided at all corners of adjacent side streets, driveways, and crosswalks
- No textured surfaces present on both wheelchair ramps at intersections

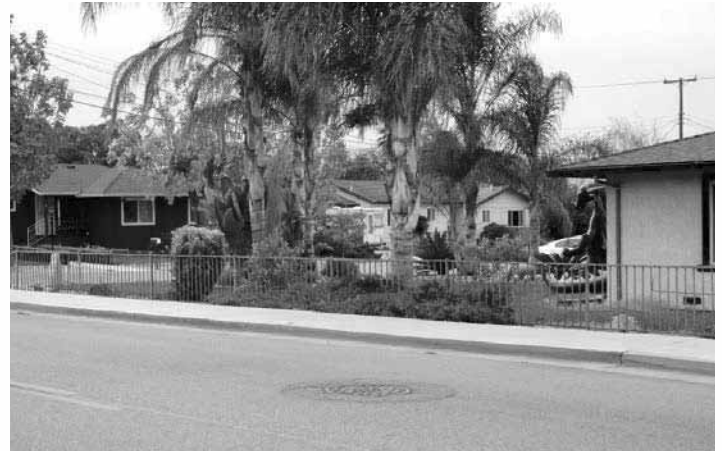
- Bus stop currently serves the Red line
- No signage to identify the bus stop
- No signpost along with system map, route map, and route timetable
- Street lighting near the bus stop
- Quality of road surface is in good condition
- Sidewalk along bus stop measures 5'0"
- Red curb at stop measures 46'0" (need repainting)
- Residential land use around the bus stop
- Bus stop location aligned with curb/parking lane
- Wheelchair ramps are provided at the upstream and downstream intersections
- ADA compliant textured ramps at nearby intersections

View of the bus stop

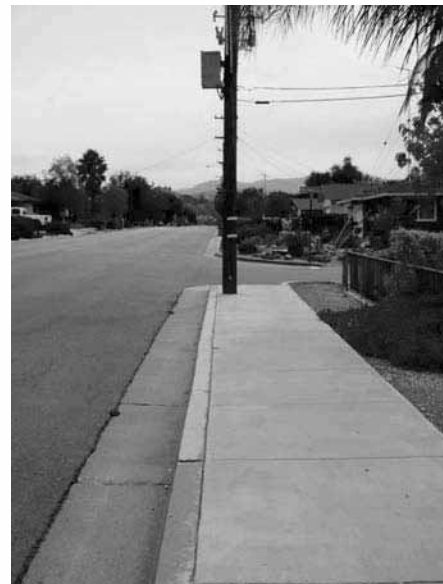
- No bus shelter or bench
- No signpost along with system map, route map, and route timetable
- No trash can or recycling bin
- No bicycle facility along the bus route
- No bicycle racks or lockers

View of the bus stop

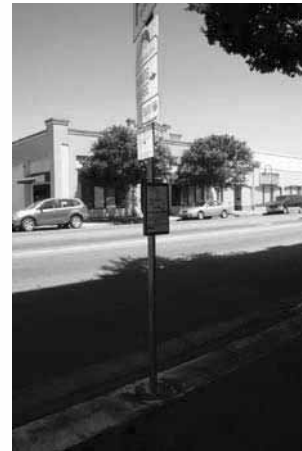
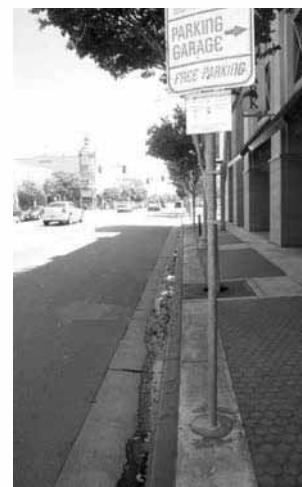
#83

- Bus stop serves the Green line
- Adequate signpost indicating bus stop
- Signpost shared with parking garage signs
- System map, route map, and route timetable in near vicinity
- Two (2) bicycle racks
- Utility boxes near the bus stop area
- Effective sidewalk: 8'0"
- No parking in both directions
- Streetlight nearby and lamppost near bus stop
- Bus stop in commercial area
- Red curb: 280'0"
- Bus will stop aligned with curb/parking lane
- Quality of road surface/concrete bus pad is good
- Wheelchair ramps provided at all corners of adjacent side streets, driveways, and crosswalks
- Continuous sidewalk
- A parking space found painted as red curb
- This stop is not marked on the LTA map

View of the bus stop

View of the bus stop from across the street

- No shelter or bench
- No trash can or recycling bin
- No bicycle facility along the bus route
- Deteriorating paint on the 280'0" red curb
- No textured surfaces at wheelchair ramps at upstream intersections

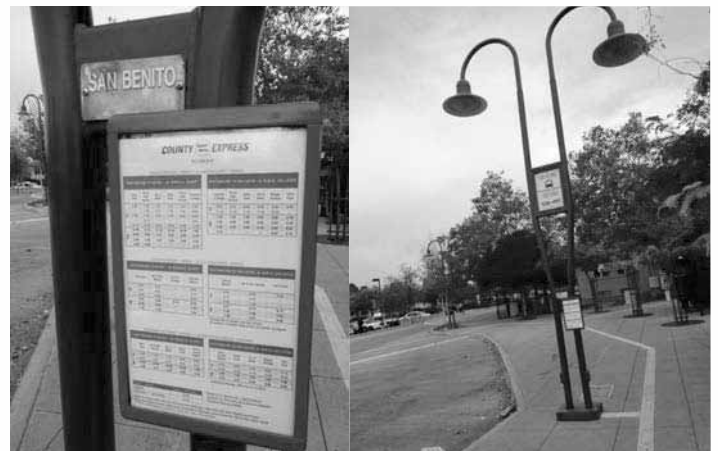
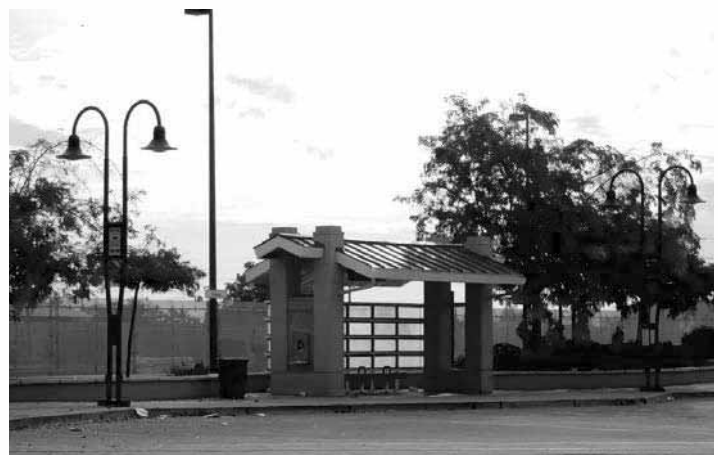
#84

- Bus stop currently serves the Inter-County line
- Bus stop located in the Gilroy Caltrain Station parking lot
- One adequate shelter
- One adequate bench
- Bus stop sharing an exclusive bus bay serving VTA
- Trash can next to shelter
- Signpost in good condition
- Timetable in good condition
- Adequate lighting in the station
- Sidewalk along bus stop measures 10'0"
- Bike racks are available
- Quality of road surface/concrete bus pad is good.
- Wheelchair ramp provided
- Textured surfaces present at all the ramps at intersection

- No red curb at stop but it's in an exclusive bus bay

View of the Bus Stop

View of the Bus Stop from across the Street

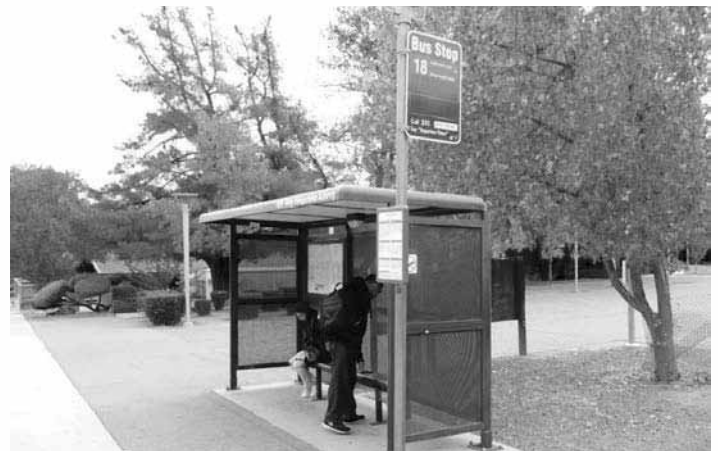
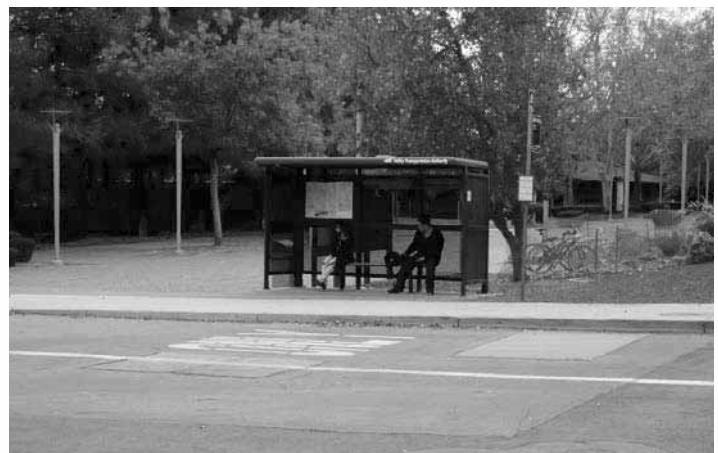
#85

- Bus stop currently serves the Inter-County line
- One (1) adequate shelter
- One (1) bench: 7' x 1' (need for repainting)
- One (1) trash can on the side of the shelter (in good condition)
- Route timetable available
- Bike racks available for 10 bicycles
- Adequate lighting in the street
- Sidewalk along bus stop measures 9'0"
- Wheelchair ramp provided
- This stop is shared with VTA

View of the bus stop

- No system map or route map
- No recycling bin
- No bicycle facility along the bus route
- No bicycle lockers

Potential need for crosswalk for pedestrians
from the other side of the campus

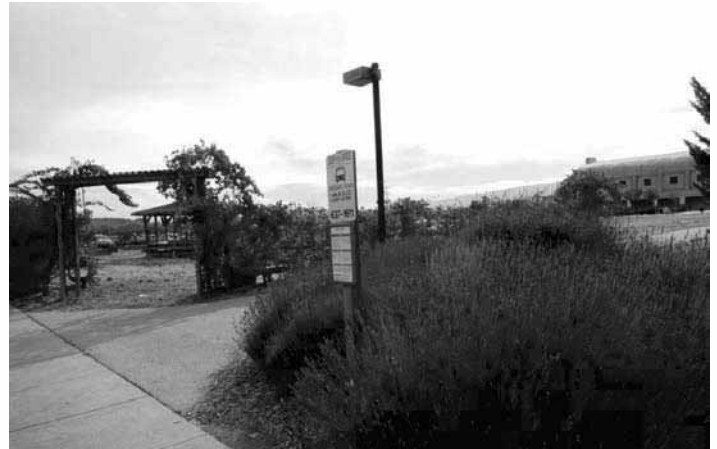
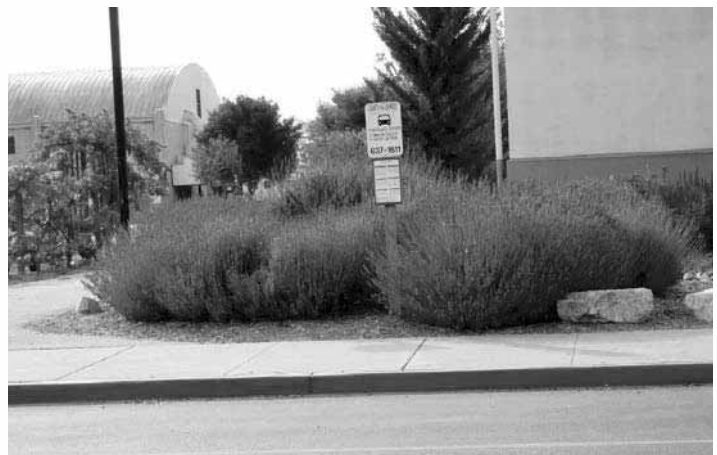
#86

- No bus shelter or bench
- No trash can or recycling bin
- No bicycle facility along the bus route
- No bicycle racks or lockers
- No wheelchair ramp
- No system map or route map

View of the bus stop

View of the bus stop from across the street

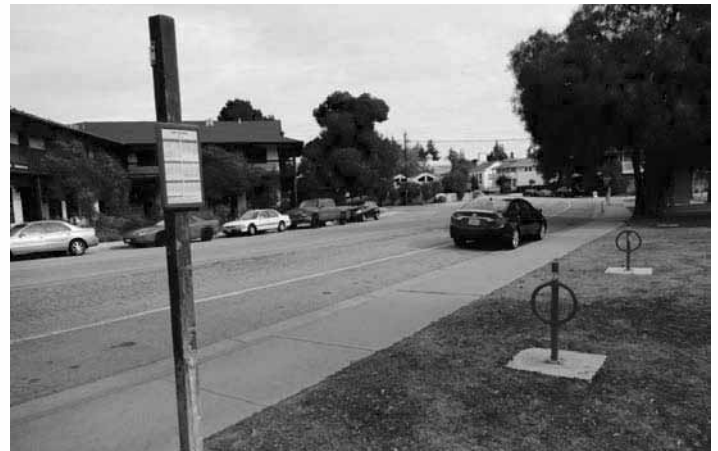
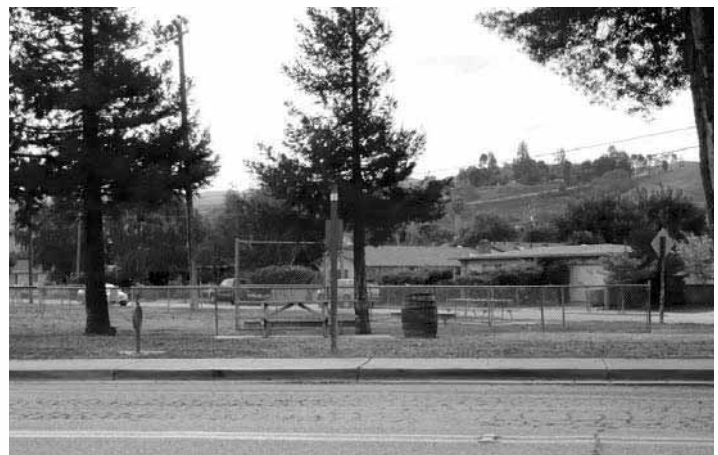
- Bus stop currently serves the Inter-County line in the City of San Juan Bautista
- One (1) bench, repaint needed (park bench adjacent to the bus stop)
- One (1) trash can
- Route timetable available
- Bike racks available for approximately six (6) bicycles
- Adequate lighting in the street
- Sidewalk along bus stop measures 4'6"
- Red curb at stop measures 40'0"
- Bus stop location aligned with curb lane
- Wheelchair ramp provided

View of the Bus Stop

- System map, route map, and route timetable are missing
- No bus shelters
- No recycling bin
- No bicycle facility along the bus route
- No bicycle lockers
- No system map or route map

View of the Bus Stop from across the Street

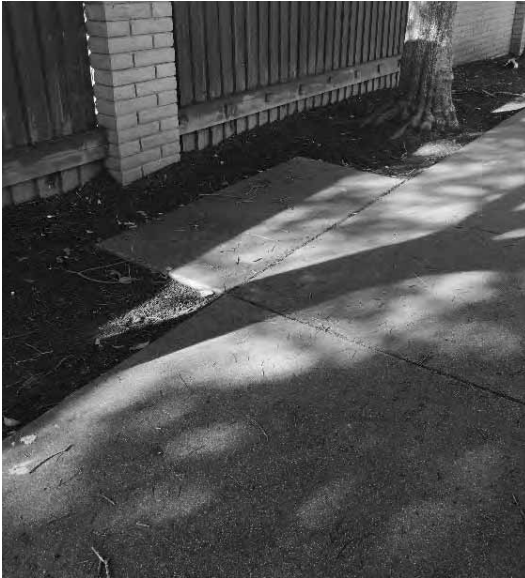
Figure 5: Existing Typical Wheelchair Pad

- ▶ The following bus stops are frequently used by wheelchair users but the stops need some improvements to accommodate them. **Figures 5 and 6** illustrate the lack of sufficient space on the sidewalk for wheelchairs.
